**WILDERNESS INVENTORY MAINTENANCE
IN BLM OREGON/WASHINGTON**
(Source: Oregon State Office Internal Guidance as of July 2007)

Year: **2010** Inventory Unit Number/Name: **Dusenbury Lake**

**FORM 1: DOCUMENTATION OF BLM WILDERNESS INVENTORY
FINDINGS ON RECORD:**

**FORM 2 - DOCUMENTATION OF CURRENT WILDERNESS
INVENTORY CONDITIONS**

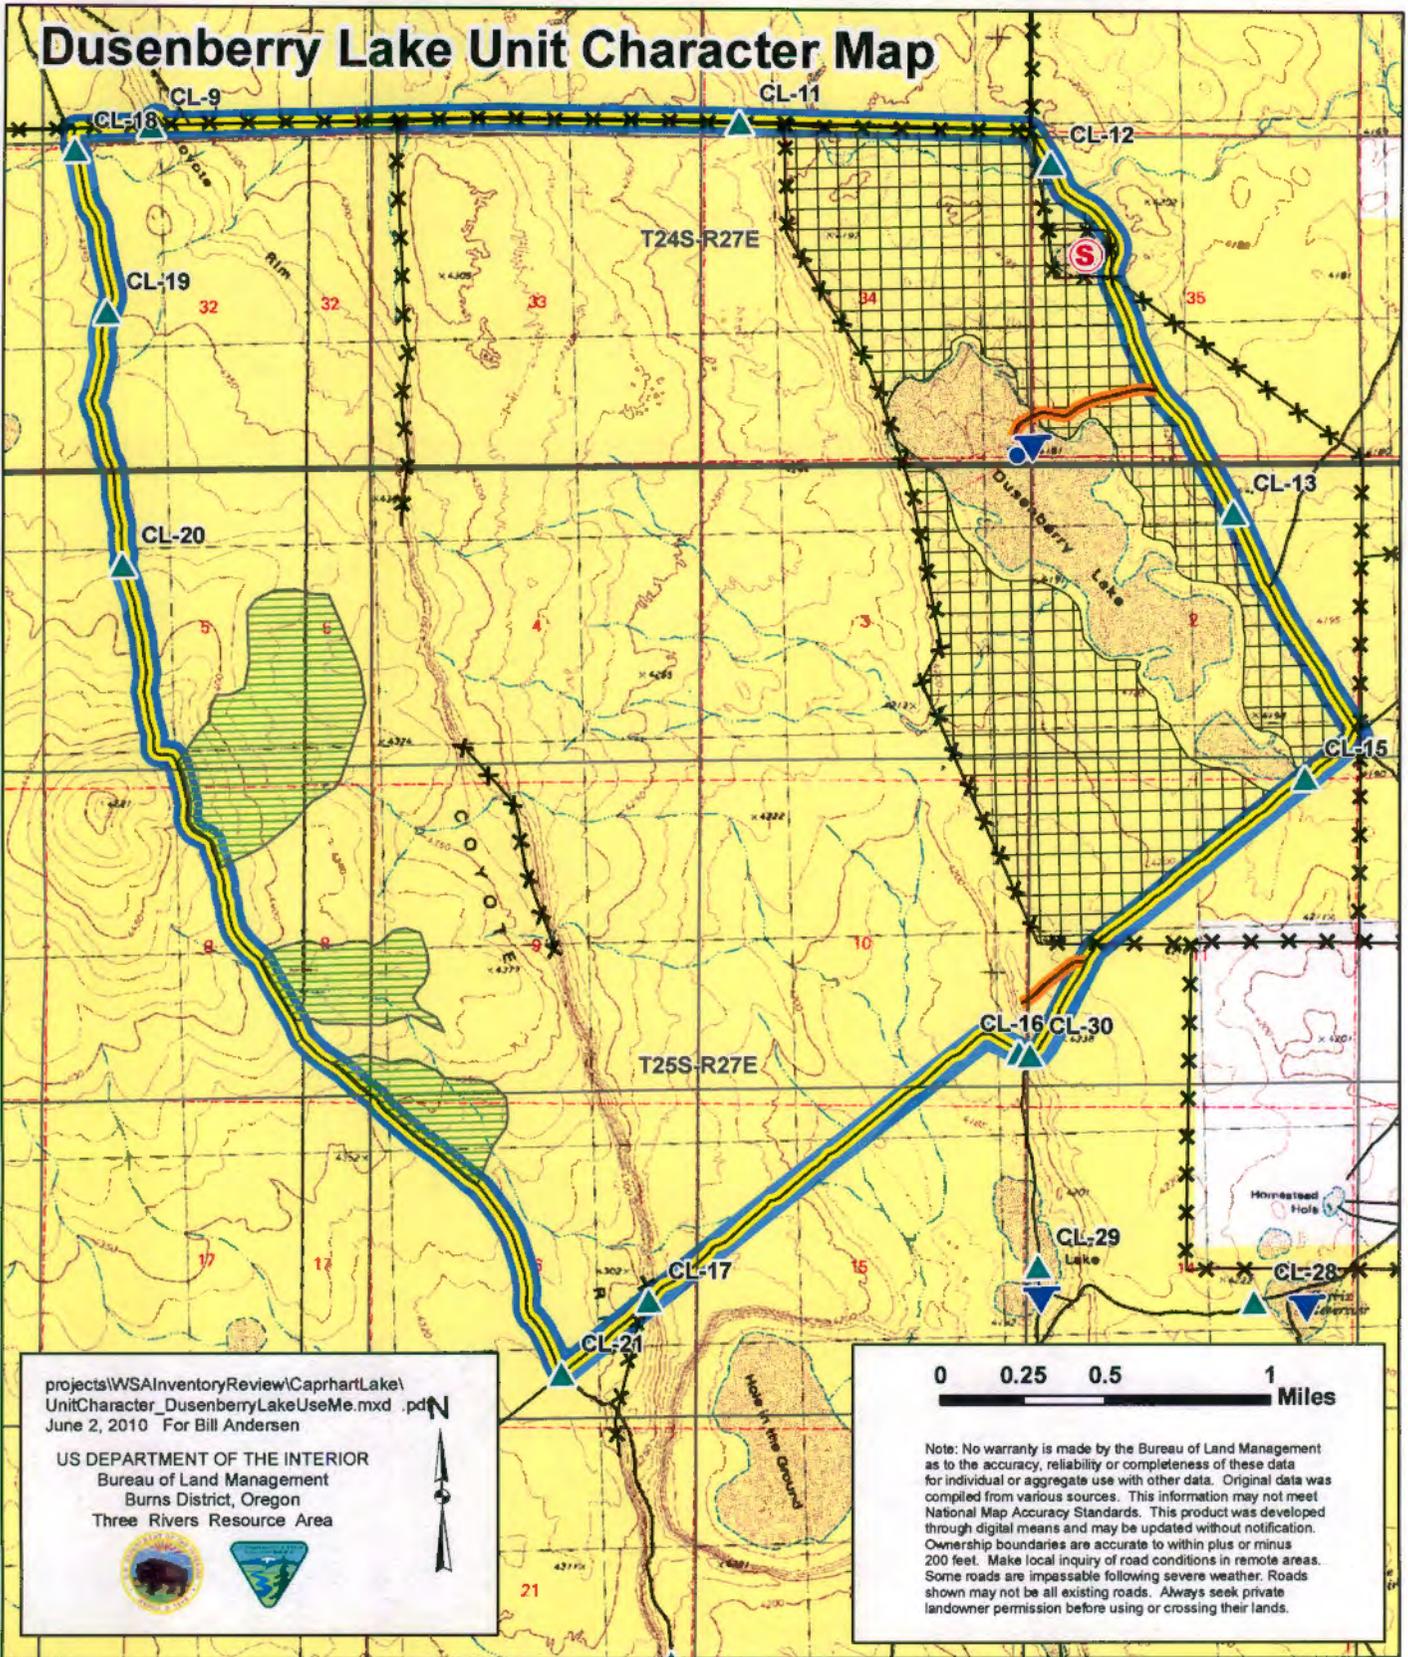
Dusenberry Lake Unit Character Map

Current Condition Description: The large 500KV power line that traverses the southern boundary of the unit has an immediate impact on the sense of naturalness. The two fences that cross the unit from north to south are only noticeable from a couple of locations. Much of the crested wheatgrass seeding has had sagebrush reestablish and appears natural. The brush beatings are also becoming reestablished with sagebrush and are noticeable only at close proximity to them.

Fences: 9 miles
Reservoirs: 1
Seedings: 1078 acres
Boundary roads: 12.7 miles
Non-boundary roads: 0.5 miles
Pipelines: 0 miles

Wells: 0
Troughs: 0
Waterholes: 1
Brushbeat: 327 acres
