Wilderness Inventory Unit Index of Documents
Alcorta Rim OR-036-030, 24 total pages

Year: 2010 **Unit Number/Name:** OR-036-030 Alcorta Rim

Unit Number/Name: Alcorta Rim OR-036-030

Wilderness Inventory Unit Name/Number (UNIT_ID): OR-036-030 -- Alcorta Rim

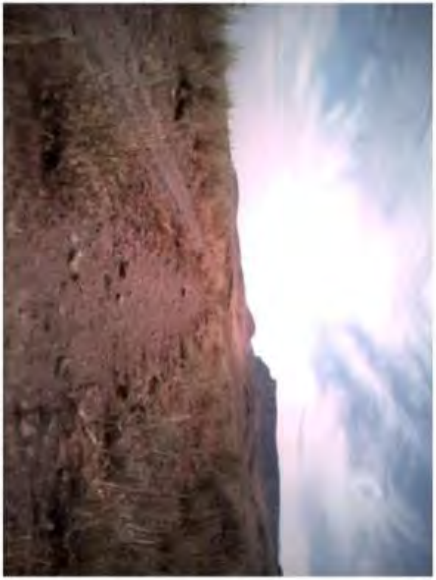
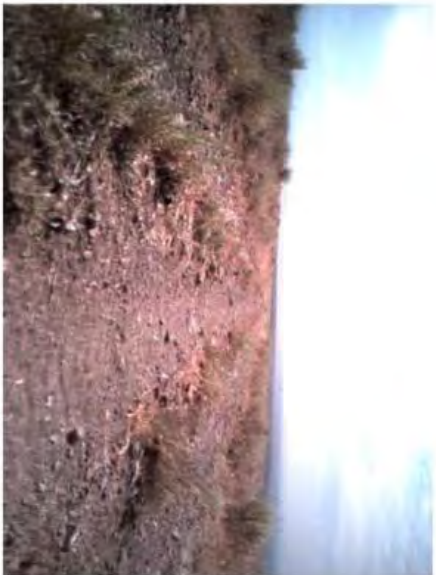
List photo point references: BLM Road 6354-0-100, photos 036-RT4-H through J and L & M; BLM route 6354-0-100, photos 036-RT4-C through F; BLM road 036-RT4, photos 036-RT4-K & L; ONDA route (way) wo38, photos AE 102 - 103, BA 37 - 47, 49, 59, and 61; ONDA route (way) wo39, photos 55 and 88; ONDA route (way) wo40, photos 50 and 57; ONDA road wo41, no photos within unit 036-030.

BLM Road sections 6354-0-100 and 036-RT4 have received regular maintenance as needed as evident from road base build-up, bladed roadbeds, drainage turnouts, culverts, and tire disturbance indicating continual use. Although route section 6354-0-100 receives limited use each year most of the travel in this section is from the top of the ridgeline down slope to the bottom because of the steep gradient and Andy Fife stream bottom.
