Wilderness Inventory Unit Index of Documents
Bogus Rim OR-036-059, 22 total pages

Year: 2011 **Unit Number/Name:** OR-036-059—Bogus Rim

FORM 2 -- DOCUMENTATION OF CURRENT WILDERNESS INVENTORY CONDITIONS

APPENDIX C – ROAD* ANALYSIS

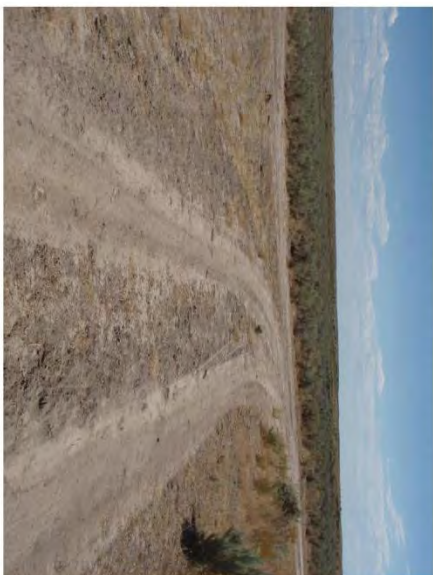
7304-0-00-D-S.JPG

Describe: BLM Road 7304-0-00 Section D-E was probably constructed sometime during the 1960s-1970s by heavy equipment, consists of natural material, and is part of the BLM Vale District Transportation Plan. No exact date can be found at this time when the road was constructed but BLM Road 7304-0-00 contains remnants of berms along both sides of the bladed roadbed and drainage ditches in segments of the road.
