Wilderness Inventory Unit Index of Documents
Broken Rim OR-034-027, 35 total pages

Prepared by:
U.S. Department of the Interior
Bureau of Land Management
Vale District Office
100 Oregon Street
Vale, Oregon 97918

Year: 2009 **Unit Number/Name:** OR-034-027 -- Broken Rim

FORM 2 -- DOCUMENTATION OF CURRENT WILDERNESS INVENTORY CONDITIONS

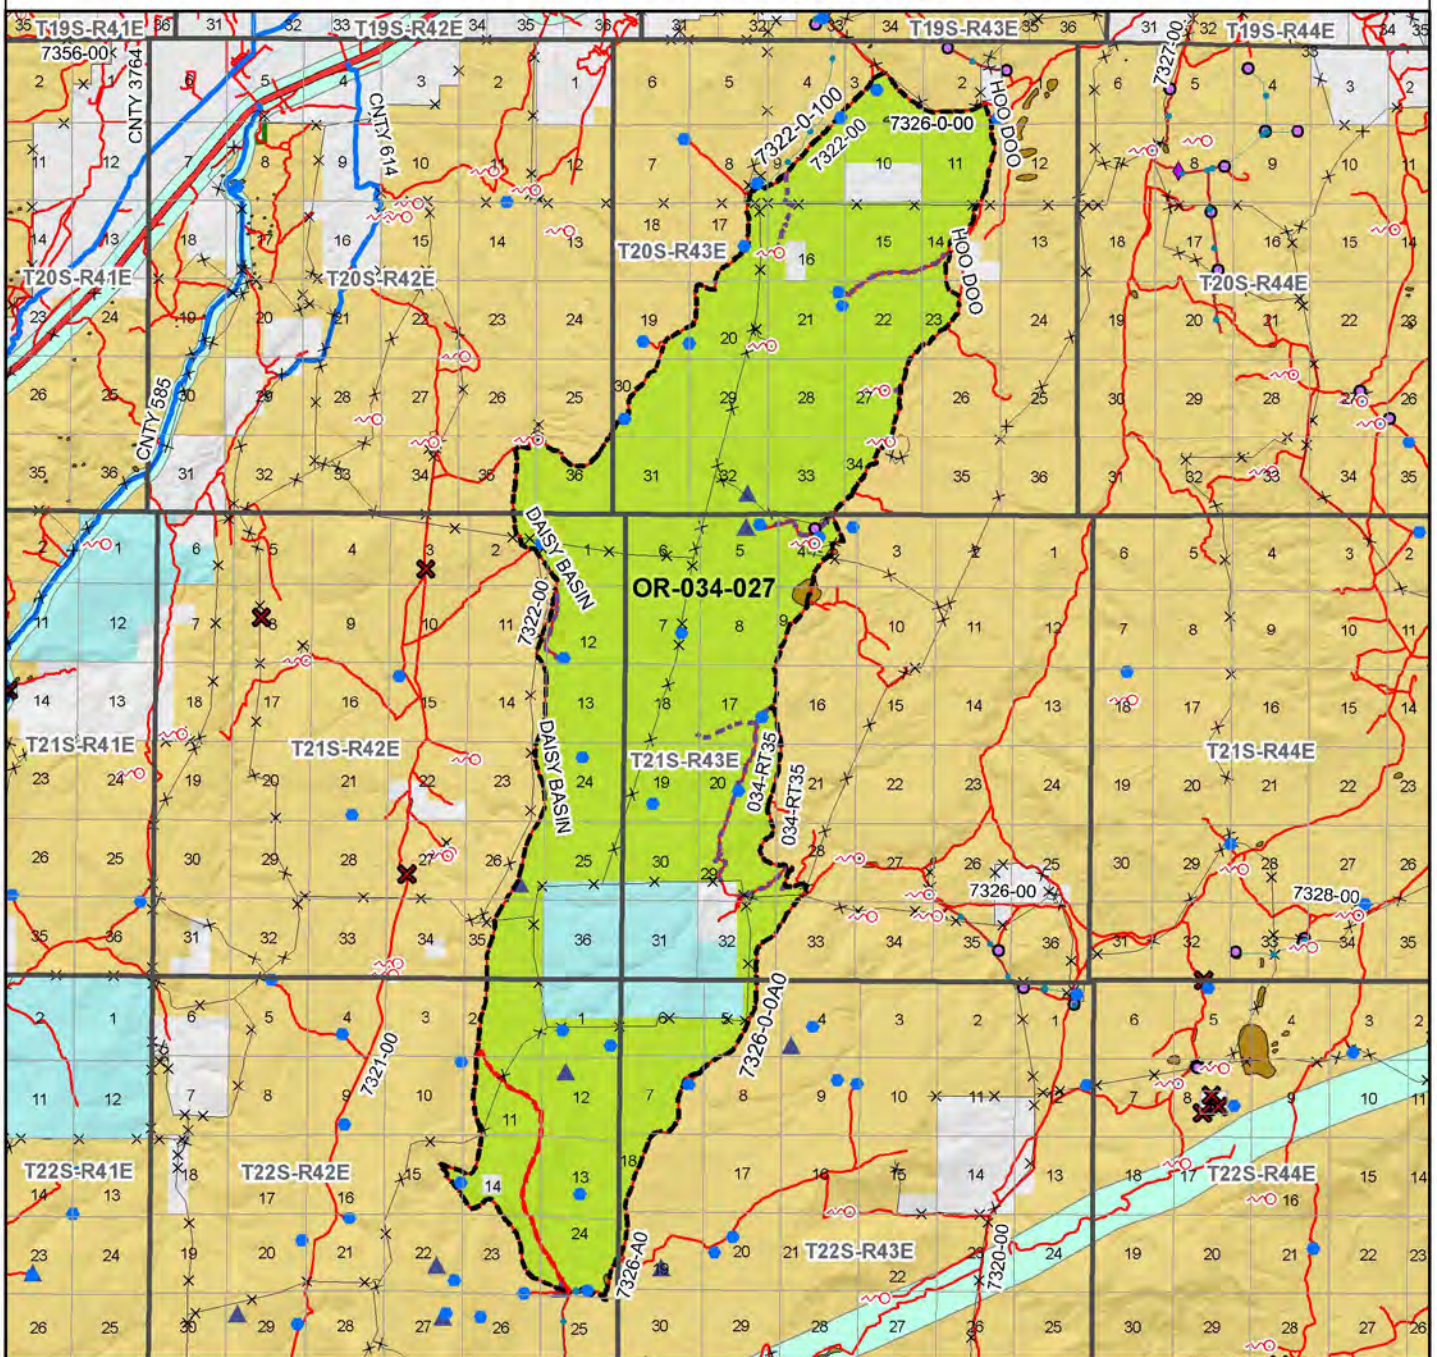
Broken Rim - OR-034-027 - Map 1 of 2

See this unit's associated Maps 1 and 2 for human imprints. There are 19 earthen reservoirs in the unit, the majority in draws on either side of the central ridge. The conspicuous Freezeout Reservoir is near the south boundary. The unit has 24.7 miles of rangeland fence, 4 rangeland fence enclosures, 4 developed springs, and 9.6 miles of 8 motorized primitive trails (MPTs). There is remnant visual evidence of one (3.9 miles) abandoned vehicle route. Presently, to the average visitor, the various vegetation treatments affecting the unit between 1964 and 1992 appear –individually and collectively – indistinguishable. Due to the presence of the ridgeline through most of the unit which provides some visual screening, and the wide distribution of, distances between, and the types/nature of the human developments within the unit relative to the unit's size, when considered individually and collectively, the developments' presence result in the unit appearing to be affected primarily by the forces of nature with the imprint of humans substantially unnoticeable to the average visitor.

Description: Much of the southern two-thirds of the unit has native shrub steppe plant communities at their potential natural condition. Map 1 displays within the unit the present documentation of 5 sage grouse leks and 3 sites of Biddle’s Lupine (a BLM special status plant species). Kane Springs harbors the Owyhee Hot Springs Snail, a BLM special status animal species, with a Strategic classification with the Interagency Special Status Sensitive Species Program.
