Wilderness Inventory Unit Index of Documents
Coyote Wells OR-036-015, 20 total pages

Year: 2007**Unit Name/Number:** Coyote Wells OR-036-015**FORM 1 -- DOCUMENTATION OF BLM WILDERNESS INVENTORY
FINDINGS ON RECORD:****1) Is there existing BLM wilderness inventory information on all or part of this area?**Yes X No **A.) Inventory Source(s) -- (X) Denotes all applicable BLM inventory files, printed maps, or published BLM Decision documents with information pertaining to this unit.****Wilderness Inventories**

Unit Name/Number: Coyote Wells OR-036-015

APPENDIX C – ROADⁱ ANALYSIS

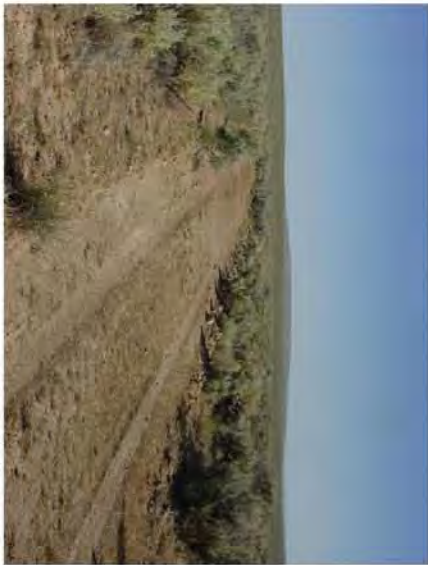
6357-0-00-B-W.JPG

On August 21, 2006 a lightning-caused wildfire burnt approximately 905 acres near the Twin Springs area within the unit. In an effort to suppress this wildfire BLM road 6357-0-C0 was bladed with a roadgrader. The road was bladed to create a mineral soil fire break to help reduce chance of the fire spreading across BLM road 6357-0-C0 into the Owyhee Canyon WSA and Hanson Canyon unit. Because the wildfire suppression made necessary the use of BLM road 6357-0-C0 as a fire containment boundary, maintenance was applied to the road, creating roadside soil berms and a bladed roadbed along most of its length bounding the Coyote Wells unit.

PHOTO_LOCATION*	DIRECTION	PHOTO_TYPE	PHOTO_DATE	COMMENTS
6357-0-00-A	SE	Route	20070416	Coyote Holes Pass
6357-0-00-A	SW	Route	20070416	Good Road
6357-0-00-C	N	Route	20060416	Visible Road
6357-0-00-H	NE	Route	20070621	Beginn Hanson Canyon Rd
6357-0-00-G	NE	Route	20070621	Visible Tracks
6357-0-00-F	NE	Route	20070621	Visible Road
6357-0-00-E	NE	Project	20070621	OR-036-015-E-NETw In Springs Corral
6357-0-00-D	N	Route	20070621	Blade Marks
6357-0-00-C	W	Route	20070621	Blade Marks
6357-0-00-B	W	Route	20070621	Blade Marks
6357-0-00-B	E	Route	20070621	Looking Back East
