Wilderness Inventory Unit Index of Documents
Deer Butte OR-036-053, 34 total pages

Year: 2011 Unit Number/Name: OR-036-053 – Deer Butte

FORM 2 -- DOCUMENTATION OF CURRENT WILDERNESS INVENTORY CONDITIONS

Unit Number/Name –OR-036-052—Deer Butte

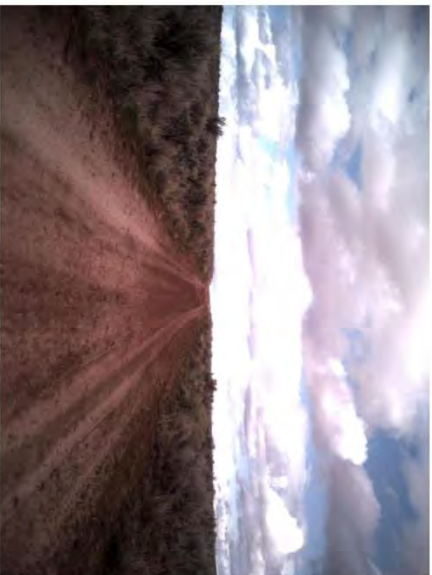
7305-0-00-A1-NW.jpg

7311-0-00-E	N	Route	20090413	Berm, Ditch.
7305-0-00-A1	NW	Route	20090413	Large and small berms. Recent tracks.
7305-0-00-A1	SE	Route	20090413	Large and small berms. Recent tracks.
7305-0-00-B1	NW	Route	20090413	Large and small berms. Recent tracks.
7305-0-00-C1	NW	Route	20090413	Small berm
7305-0-00-C1	SE	Route	20090413	Cattle guard, Fence.
7305-0-00-D1	W	Route	20090413	Ditch and berm.
7305-0-00-D1	E	Route	20090413	Ditch and berm.
7305-0-00-E1	W	Route	20090413	Ditch.
7305-0-00-E1	W	Route	20090413	Ditch.
7305-0-00-F1	E	Route	20090413	Ditch.
7305-0-00-G1	W	Route	20090413	Ditch, Berm.
7305-0-00-G1	E	Route	20090413	Ditch, Berm.
7305-0-00-H1	E	Route	20090413	Ditch.
7305-0-00-H1	E	Route	20090413	Ditch.
7305-0-00-B1	SE	Route	20090413	Large and small berms. Recent tracks.

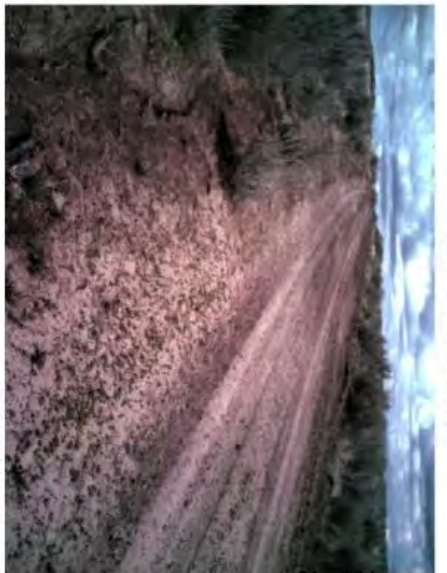
7311-0-00-B-NE.jpg

The existing road contains berms along the majority of both sides of the bladed roadbed. Road drainage ditches can still be observed in BLM photo 7311-0-00-B-NE. The majority of the berms along the roadbed are now covered mostly by perennial grasses and some shrubs along with annual plants since the original berm width has not been bladed for many years. Currently in an effort to reduce weed establishment along roads on public land the BLM blades only the roadbed when performing maintenance and not the entire width of the road that included berms when the road was originally constructed.
