Wilderness Inventory Unit Index of Documents
Freezeout Ridge OR-034-028, 25 total pages

Year: 2008 **Unit Number/Name:** OR-034-028 -- Freezeout Ridge

FORM 2 -- DOCUMENTATION OF CURRENT WILDERNESS INVENTORY CONDITIONS

Unit Name and Number: OR-034-028 -- Freezeout Ridge

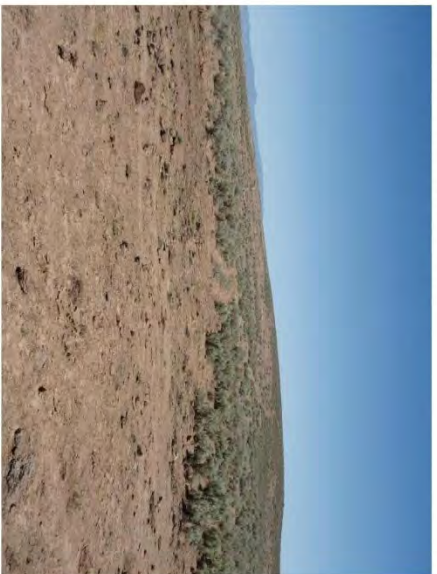
034-7321-0-0A0-A-E.jpg

PHOTO_LOCATION*	DIRECTION	PHOTO_TYPE	PHOTO_DATE	COMMENTS
034-7321-0-0A0-A	W	Route	20080620	Visible vehicle usage, BLM sign.
034-7321-0-0A0-A	E	Route	20080620	Visible vehicle usage.
034-7321-0-0A0-A	S	Route	20080620	Visible vehicle usage.
034-7321-0-0A0-B	NW	Route	20080620	Visible usage, BLM sign
034-7321-0-0A0-B	E	Route	20080620	Visible usage.
034-7321-0-0A0-B	S	Route	20080620	Cattle gate, visible route use.
034-7322-0-100-G	N	Route	20080620	Route use, cattle fence.
034-7322-0-100-H	S	Route	20080620	Signs of route use, cattle fence.
034-7322-0-100-I	N	Route	20080620	Signs of route use.
034-7322-0-100-I	S	Route	20080620	Signs of vehicle use, cattle gate.
034-7322-0-100-J	N	Route	20080620	Signs of vehicle use.
034-7322-0-100-K	S	Route	20080620	Cattle gate.
034-7322-0-100-L	N	Route	20080620	Signs of vehicle use.
034-7322-0-100-L	S	Route	20080620	Signs of vehicle use.
034-7322-0-100-L	W	Route	20080620	Visible route use.

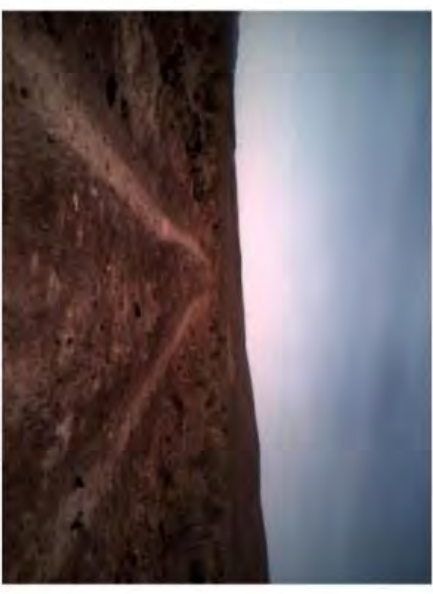
7322-0-100-M-S.JPG

034-7322-0-100-M	N	Route	20080724	Route
034-7322-0-100-M	S	Route	20080724	Signs of vehicle use.
034-7322-0-100-M	S	Route	20080724	Signs of vehicle use.
034-7322-0-100-N	N	Route	20080724	Signs of vehicle use.
034-7322-0-100-N	S	Route	20080724	Signs of vehicle use.
034-7322-0-100-O	N	Route	20080724	back, beginning of route 7322-0-100
034-7322-0-100-P	S	Route	20080724	front, beginning of route 7322-0-100
034-7322-0-100-P	E	Route	20080724	route 7322 0 -100 with rubber horse
034-7322-0-100-Q	N	Route	20080724	back route 7322 0 100 with rubber horse
034-7322-0-100-Q	S	Route	20080724	front, end of route 7322 0 -100
034-7322-0-100-Q	N	Route	20080724	back, end of route 7322 0 100
