Wilderness Inventory Unit Index of Documents
Grassey OR-036-068, 22 total pages

Year: 2011 **Unit Number/Name:** OR-036-068--Grassy

Unit Number/Name: OR-036-068 — Grassey

WILDERNESS CHARACTERISTICS INVENTORY

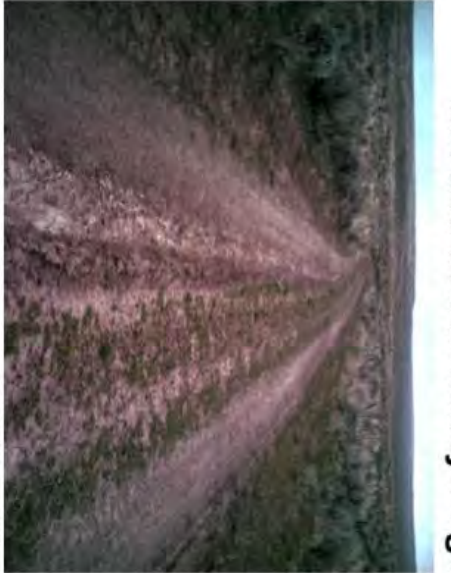
036-RT18-A-SW.jpg

BLM has conducted maintenance to BLM Road 036-RT18 over time as needed to keep this route passable. Earthen berms on the edge of the road in photographs 036-RT18-A-SW, C-SW, and E-E show maintenance work that has been performed on BLM Road 036-RT18 in the past since the road was constructed. Although it has been many years since maintenance has been performed on the entire length of BLM Road 036-RT18, it is evident from photographs BLM has taken, that little to no maintenance is needed to keep the roadbed in good operational condition.

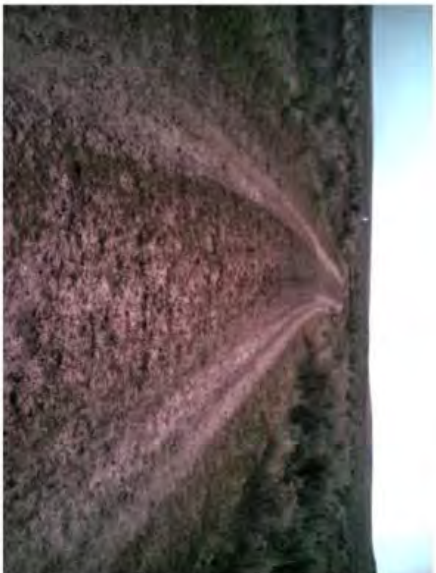
036-RT18-C-SW.jpg

Existing roadside berms are not particularly pronounced in some segments of BLM Road 036-RT18, especially in areas where the roadway travels over small hill tops (BLM photos 036-RT18-A-NE) or in relatively flat topography (BLM photos 036-RT18-A-SW) since these areas require little maintenance to remain passable by vehicles. In other areas along BLM Road 036-RT18 some of the ditches and berms are covered with brush as well as sediment filling in the some of the remaining depth of ditches (BLM photos 036-RT18-C-SW and E-W).

Describe: Many sections of BLM Road 036-RT18, photos 036-RT18-C-SW and E-W contain ditches along the roadbed to drain water from the road and are usually part of the original construction. Therefore, the drainage ditches are considered an improvement even though many areas along the road no long contain this feature because of sediment filing in drainage depressions..
