Wilderness Inventory Unit Index of Documents
Grenke OR-036-055, 25 total pages

Year: 2011 **Unit Number/Name:** OR-036-055--Grenke

Unit Number/Name: OR-036-055—Grenke

Wilderness Characteristics Inventory Area Unique Identifier: OR-036-055 Grenke

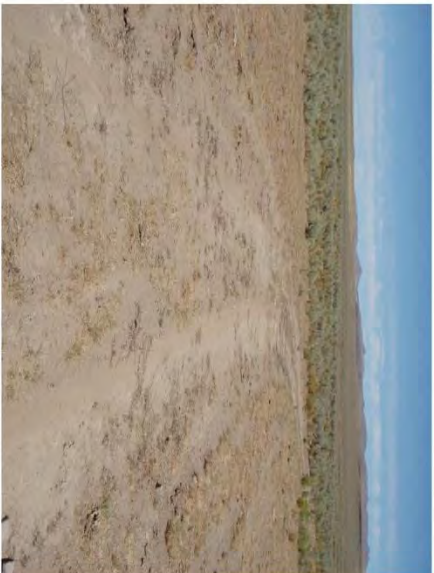
036-RT8-H-NE.JPG

BLM has conducted maintenance to BLM Road 6368-00 over time as needed to keep this route passable. Earthen berms on the edge of the road in photographs 036-RT8-A-W, B-NE, H-NE, J-N, K-N, K-SEC, 6368-0-00-B-E, B-W, C-W, E-E, and F-W show maintenance work that has been performed on BLM Road 6368-0-0 in the past since the road was constructed. Although it has been many years since maintenance has been performed on the entire length of BLM Road 6368-00, it is evident from photographs BLM has taken, that little to no maintenance is needed to keep the roadbed in good operational condition.
