Wilderness Inventory Unit Index of Documents
Jordan Craters Contiguous OR-036-092, 41 total pages

Year: 2011 Unit Number/Name: OR-036-092 – Jordan Craters (Contiguous)

FORM 2 -- DOCUMENTATION OF CURRENT WILDERNESS INVENTORY CONDITIONS

Unit Number/Name – OR-036-052 – Jordan Craters (Contiguous)

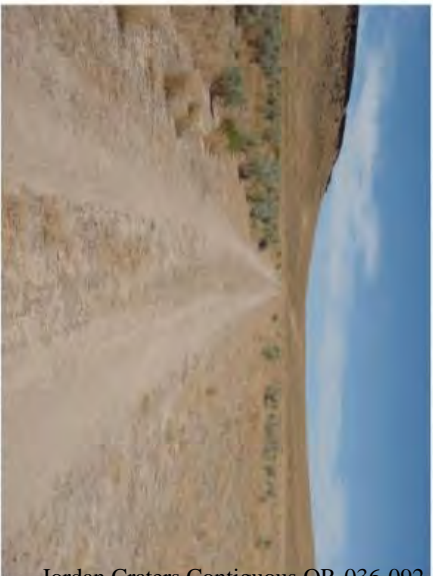
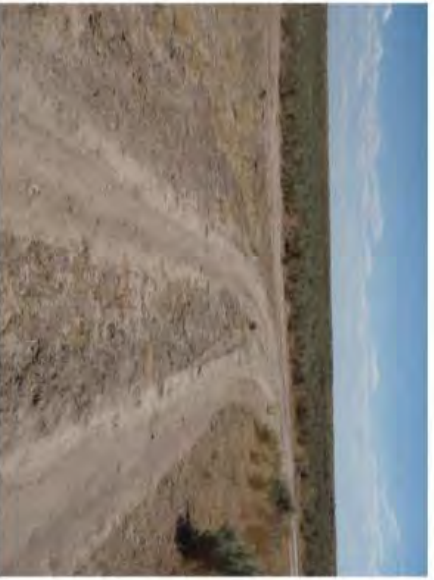
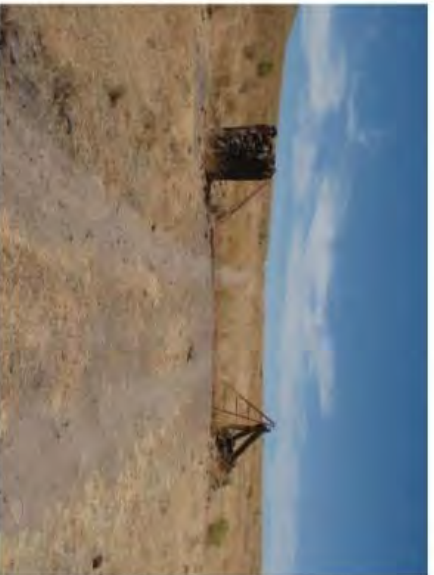
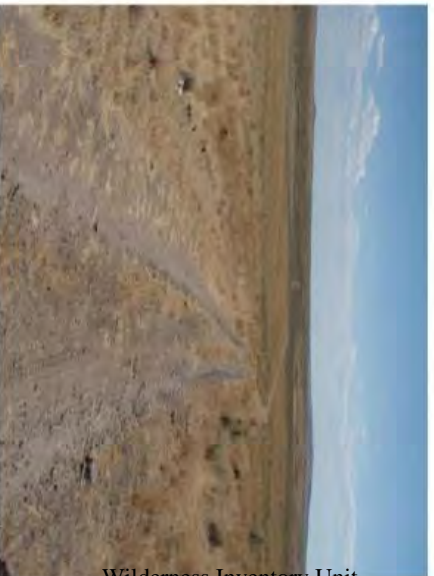
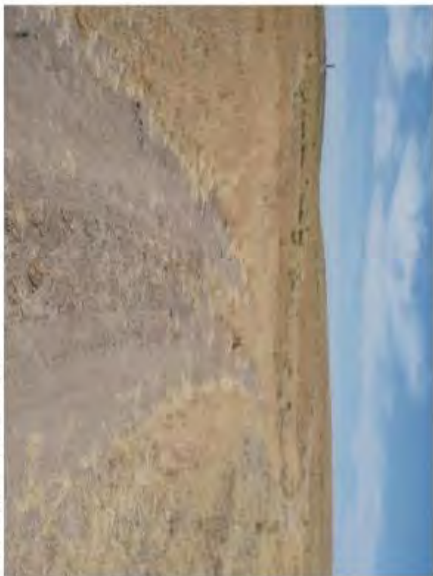
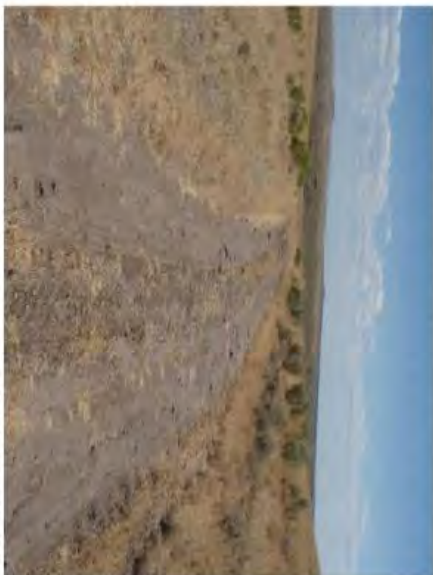
BLM Road 7304-0-00 section D-E has received regular use as evident from a wide roadway and tire disturbance indicating continual use (BLM photos 7304-0-00-A through D and ONDA photos DB 030 and 035). BLM Road 7304-0-00 has annual seasonal use as evidence by the lack of perennial vegetation in all road segments and by well-used bare ground where vehicle tire tracks can be observed. BLM Road 7304-0-00 Section D-E is well traveled, wide along most of its length, and is clearly defined on the landscape. BLM Road 7304-0-00 is also used on a seasonal basis by hunters, ranchers, BLM staff, and recreation enthusiasts.
