Wilderness Inventory Unit Index of Documents  
**Schnable Creek OR-034-057, 35 total pages**

**Unit Number/Name – OR-034-057 — Schnable Creek**

**APPENDIX C – ROAD\* ANALYSIS**

**Wilderness Inventory Unit Name/Number: OR-034-057—Schnable Creek**

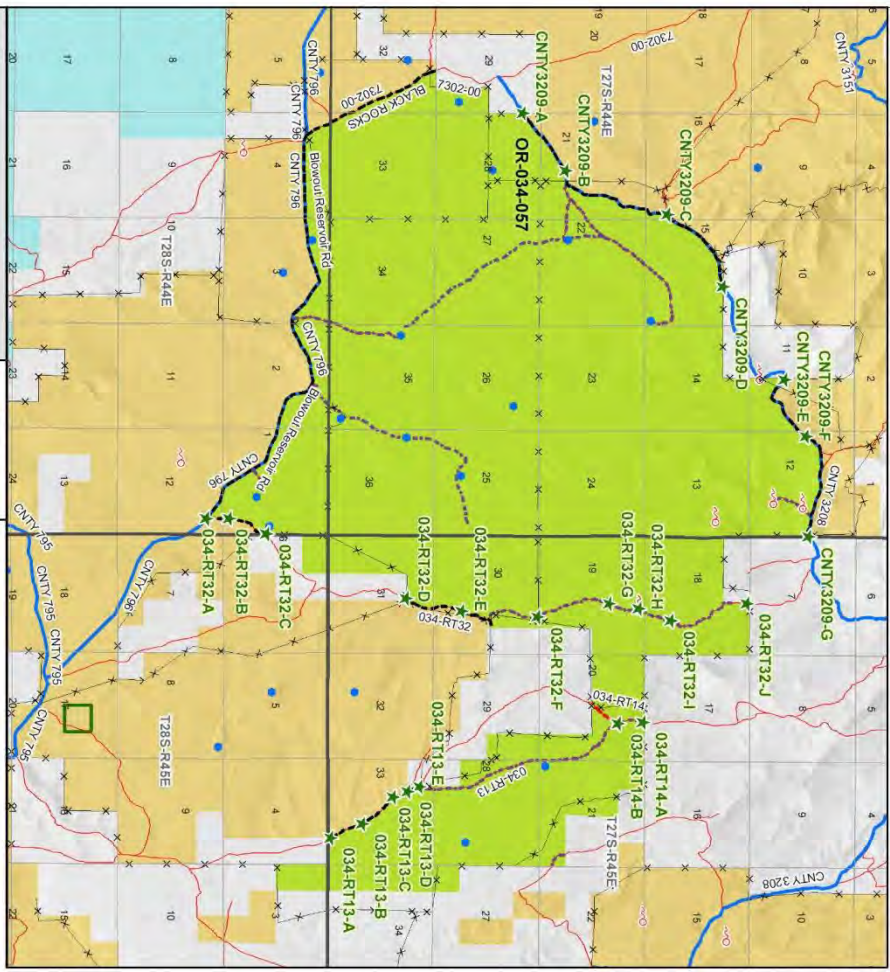
Wilderness Characteristics - BLM Photo Points  
Schnable Creek - OR-034-057

PHOTO LOCATION	DIRECTION	PHOTO TYPE	PHOTO DATE	COMMENTS
CNTY3209-A	NE	Route	20080822	Start of route looking at route
CNTY3209-A	SW	Route	20080822	Looking at start of route. Good route.
CNTY3209-B	E	Route	20080822	no sign of maintenance, but easy to drive on.
CNTY3209-B	W	Route	20080822	no sign of maintenance, but easy to drive on.
CNTY3209-B	N	Project	20080822	OR-034-057-B-N, Drainage
CNTY3209-C	S	Route	20080822	Gravel added.
CNTY3209-C	W	Route	20080822	Road off of route.
CNTY3209-D	SW	Route	20080822	End of route looking at route berms
CNTY3209-D	NE	Route	20080822	Looking at end of route.
CNTY3209-E	E	Route	20080822	Start of second route.
CNTY3209-E	W	Route	20080822	Easily passable.
CNTY3209-F	S	Route	20080822	Flat, easily passable, no sign of maintenance
CNTY3209-F	N	Route	20080822	End of second route looking at route
CNTY3209-G	S	Route	20081031	front, beginning of 034-RT32, intersection w/ CNTY 796
CNTY3209-G	N	Route	20081031	back, beginning of 034-RT32

CNTY3209-H	S	Route	20081031	front
CNTY3209-H	N	Route	20081031	back
CNTY3209-I	S	Route	20081031	front
CNTY3209-I	N	Route	20081031	back
CNTY3209-J	S	Route	20081031	front, cattle gate
CNTY3209-J	W	Route	20081031	OR-034-057-D-W fence
CNTY3209-K	S	Route	20081031	back
CNTY3209-K	N	Route	20081031	front
CNTY3209-L	S	Route	20081031	front
CNTY3209-L	W	Route	20081031	OR-034-057-E-W fence
CNTY3209-M	S	Route	20081031	back
CNTY3209-M	N	Route	20081031	front
CNTY3209-N	S	Route	20081031	front
CNTY3209-N	W	Route	20081031	OR-034-057-F-W fence
CNTY3209-O	S	Route	20081031	back
CNTY3209-O	N	Route	20081031	front
CNTY3209-P	S	Route	20081031	front
CNTY3209-P	W	Route	20081031	OR-034-057-G-W fence
CNTY3209-Q	S	Route	20081031	back
CNTY3209-Q	N	Route	20081031	front
CNTY3209-R	S	Route	20081031	front
CNTY3209-R	W	Route	20081031	OR-034-057-H-W fence
CNTY3209-S	S	Route	20081031	back
CNTY3209-S	N	Route	20081031	front
CNTY3209-T	S	Route	20081031	front

CNTY3209-T	W	Route	20081031	OR-034-057-I-W fence
CNTY3209-U	S	Route	20081031	back
CNTY3209-U	N	Route	20081031	front
CNTY3209-V	S	Route	20081031	front
CNTY3209-V	W	Route	20081031	OR-034-057-J-W fence
CNTY3209-W	S	Route	20081031	back
CNTY3209-W	N	Route	20081031	front
CNTY3209-X	S	Route	20081031	front
CNTY3209-X	W	Route	20081031	OR-034-057-K-W fence
CNTY3209-Y	S	Route	20081031	back
CNTY3209-Y	N	Route	20081031	front
CNTY3209-Z	S	Route	20081031	front
CNTY3209-Z	W	Route	20081031	OR-034-057-L-W fence

Note: The BLM Wild Char PhotoPoints displayed on the map are labeled with their Photo Locations. The BLM Photo Log table shows above lists the pictures taken at their respective Photo Locations. Multiple photos may be taken at each Photo Location. Scenery and Project Photo Type pictures have their photo names provided in the Comments field.

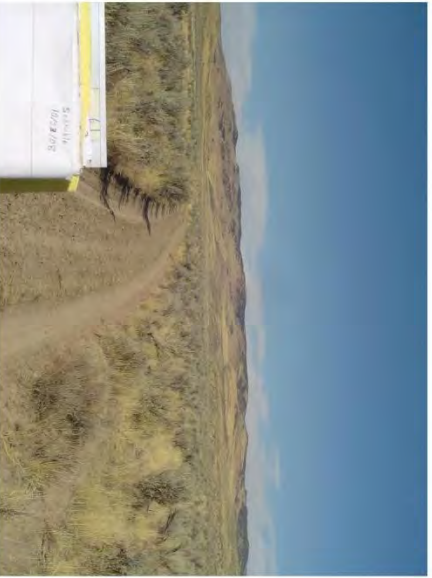
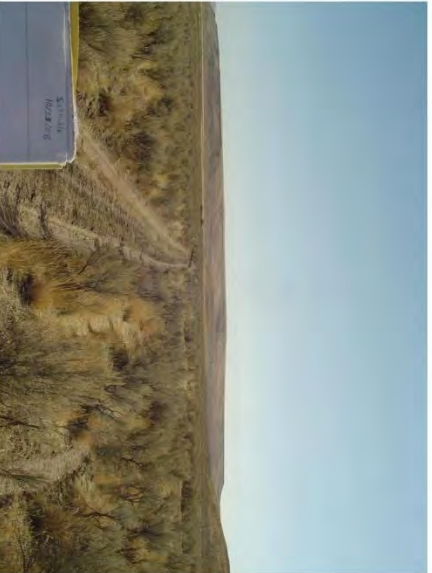
**Comments:** Between photo points (PP) 034-RT13-A and 034-RT13-D, maintenance would continue to be accomplished to provide for continued access to the private land parcel (starting in section 33 from a south approach).

Between photo points (PP) 034-RT13-A and 034-RT13-D the evidence of the recent hand tooled maintenance tasks and the extent of vehicle tracks indicate continued use of the route on a relatively regular basis.

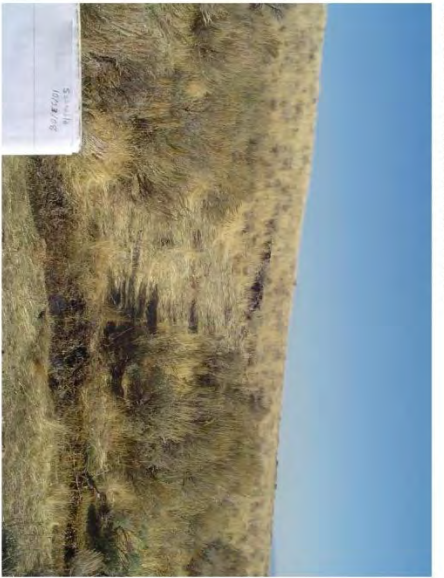
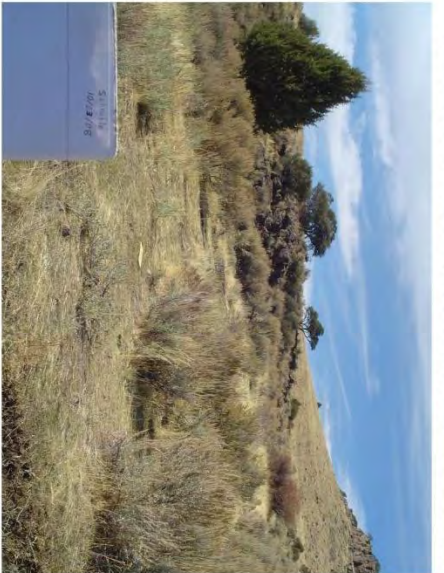
From PP 034-RT13-D north to where it junctions with 034-RT14 (PP 034-RT14-B), the route has no indications of maintenance, with this segment not in good condition and no identified need to have maintenance performed on it. (NOTE: Also see Road Analysis form for 034-RT14.)

From PP 034-RT13-D north to where it junctions with 034-RT14 (PP 034-RT14-B), there is no evidence of relatively regular use of the route.

**Comments:** Route is not in good condition. Another route (County 3209 road -- see its Road Analysis form for this BLM inventory unit) serves as the primary connector to the same large private land parcel which this 034-RT14 also goes to.
