Wilderness Inventory Unit Index of Documents
Scott Butte OR-036-019, 25 total pages

Year: 2011 **Unit Number/Name:** OR-036-019 -- Scott Butte

FORM 2 -- DOCUMENTATION OF CURRENT WILDERNESS INVENTORY CONDITIONS

Wilderness Inventory Unit Name/Number (UNIT_ID): OR-036-019 -- Scott Butte

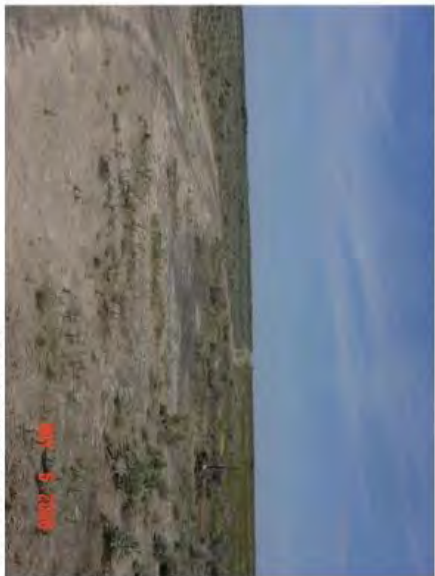
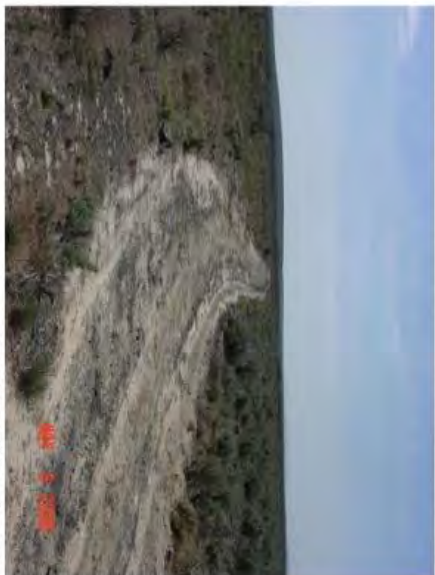
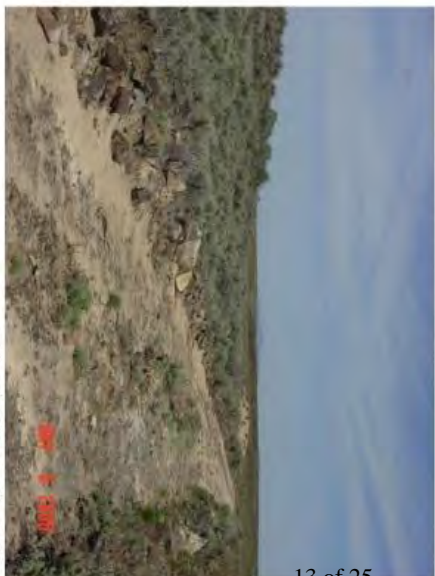
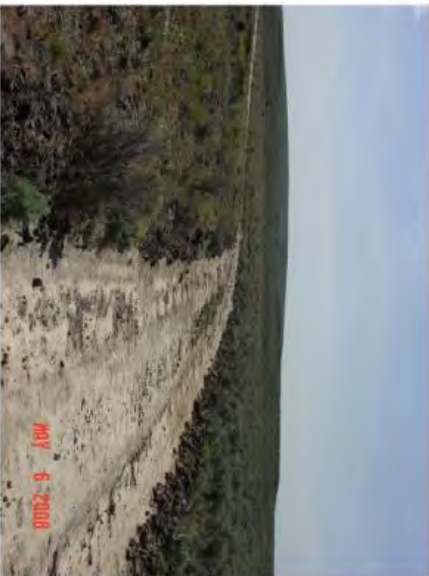
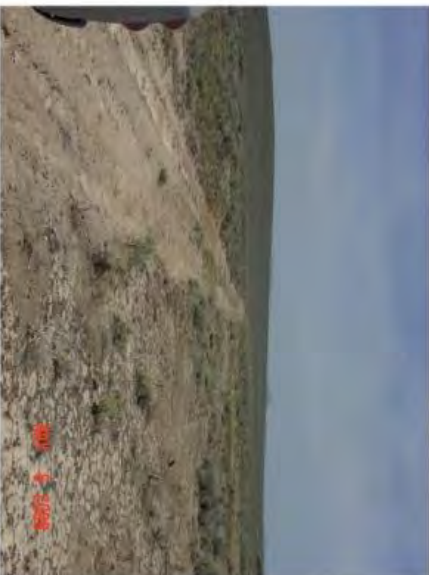
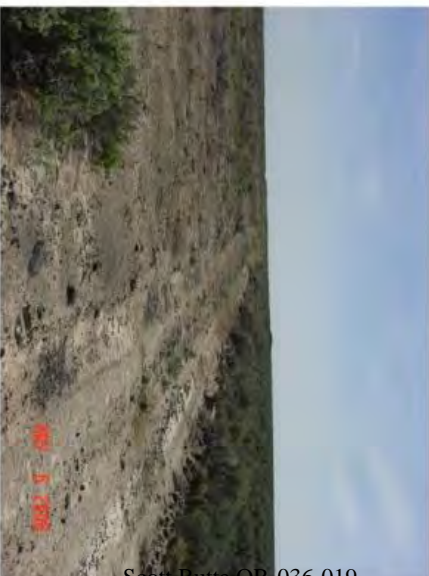
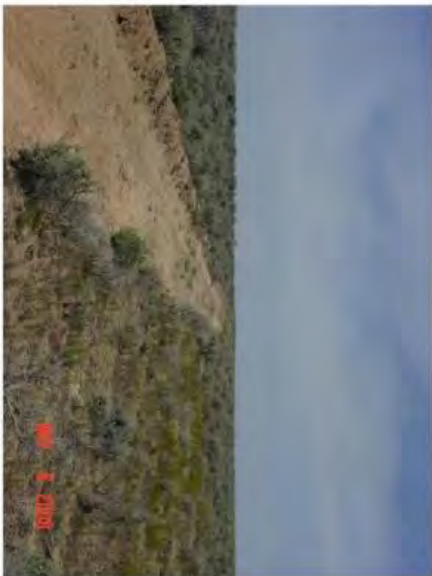
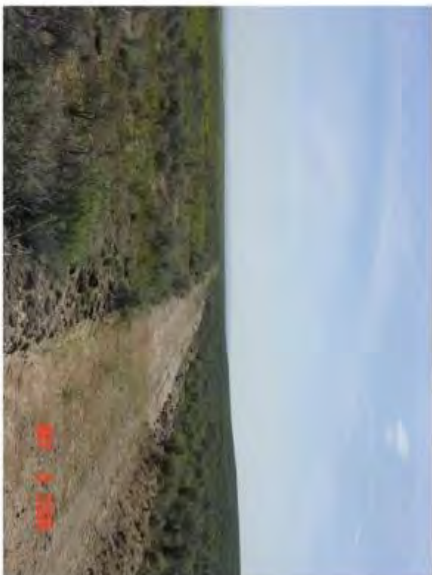
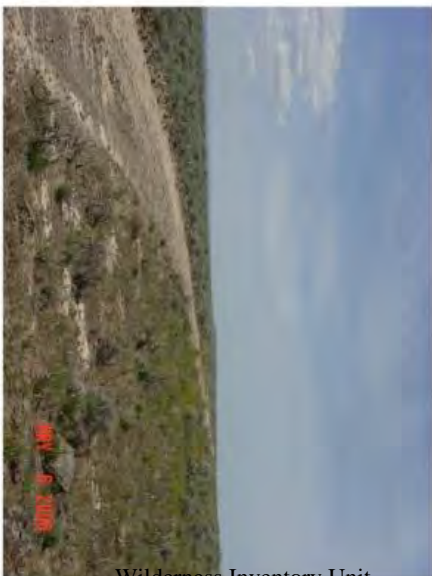
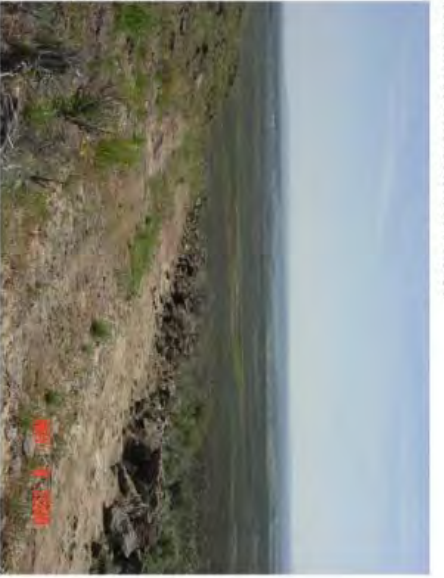
List photo point references: Malheur County Road 790; BLM photos 036-CNTY790 - A through E; ONDA route (way) SB7; photos AD 027, 028.

Describe: Information on when and how Malheur County Road 790 was constructed is not available. Sometime in the mid-1900s the road surface was bladed and berms added on the roadsides, using a road-grader. The bladed road and old berms can clearly be seen along the route as evident in BLM photographs 036-CNTY790 A through E. Although vegetation now covers much of the original berms, rows of rock material pushed aside by heavy equipment are apparent outside of any new maintenance performed on Malheur County Road 790 in 2006. BLM's photographs clearly show sections of Malheur County road 790, throughout the entire 13.0 mile length, where the road has been bladed and contain remnants of berms on sides of the road. Because wildfire suppression made it necessary to use Malheur County Road 790 as a fire access route in 2006, maintenance was applied to the road, creating roadside soil berms and a bladed roadbed along segments of its length where it is the boundary between unit OR-036-019 and the Saddle Butte WSA (OR 3-111). The roadbed of Malheur County Road 790 consists of natural on-site materials.

Explain: During 2006, BLM responded to a wildfire within the Saddle Butte Allotment by utilizing Malheur County Road 790 and other routes. To facilitate the suppression of this wildfire it was necessary to improve access for heavy equipment over Malheur County Road 790. The roadbed of Malheur County Road 790 was bladed along various segments with a road-grader as required as evident in the series of photographs BLM recorded in 2008 (BLM photos, 036-CNTY790 - A through E).

Malheur County Road 790 has annual seasonal use as evidence by the lack of vegetation in all road segments and by well-used bare ground where vehicle tires tracks can be observed. The road is well traveled, wide along most of its length, and is clearly defined on the landscape. The road is also used on a seasonal basis by hunters and recreation enthusiasts.

Explanation: BLM has determined that Malheur County Road 790 meets the definition of a road as stated in sections IV, VI-A, and VII above. County Road 790 was constructed by mechanical equipment, has been maintained since being constructed, would be approved to be maintained by management as needed if the road base became impassable, and has regular and continuous seasonal use.
