Wilderness Inventory Unit Index of Documents  
**Selle Gap OR-034-107, 28 total pages**

Year: 2010 Unit Number/Name: OR-034-107 — Selle Gap

**FORM 1 -- DOCUMENTATION OF BLM WILDERNESS INVENTORY  
FINDINGS ON RECORD**

## **FORM 2 -- DOCUMENTATION OF CURRENT WILDERNESS INVENTORY CONDITIONS**

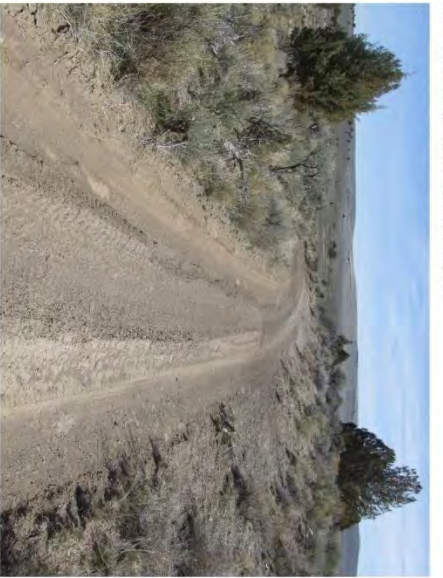
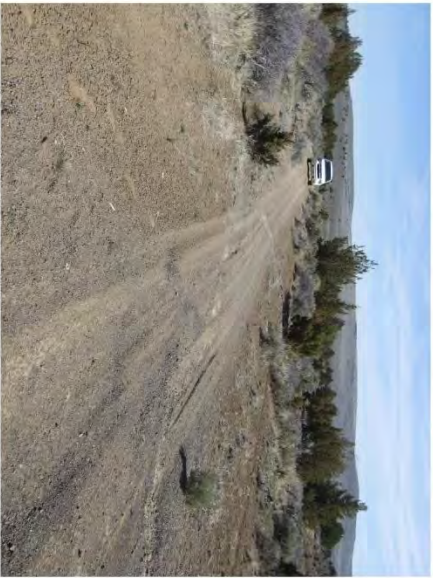
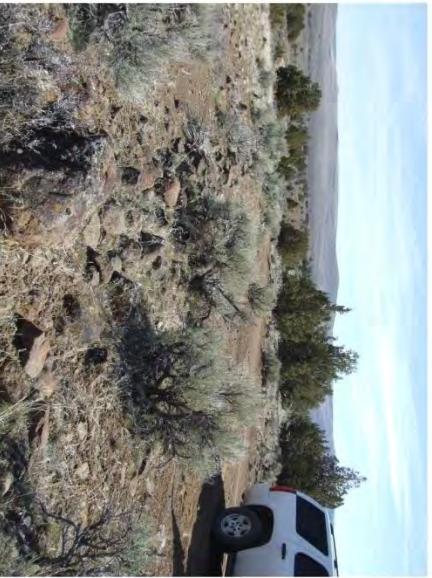
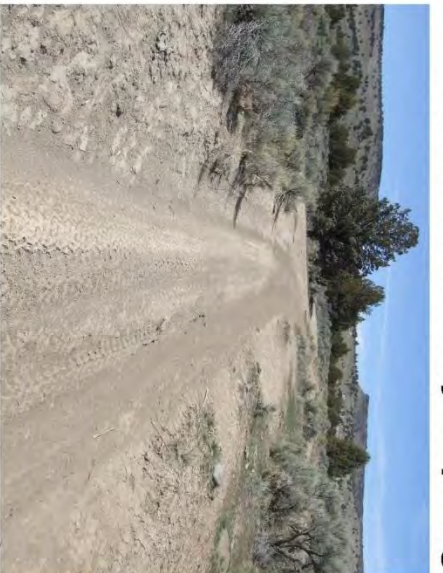
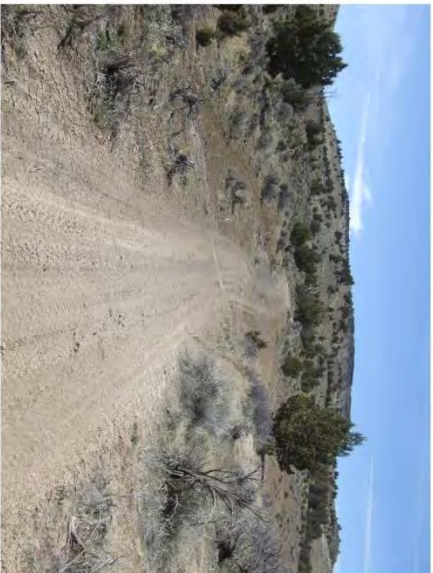
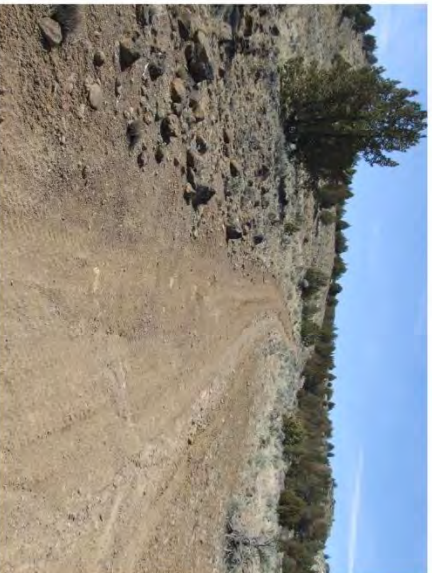
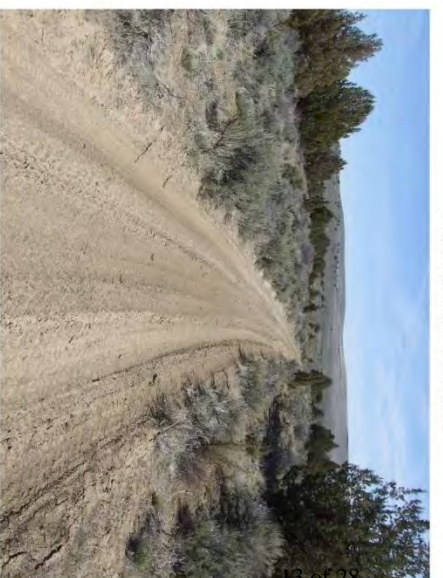
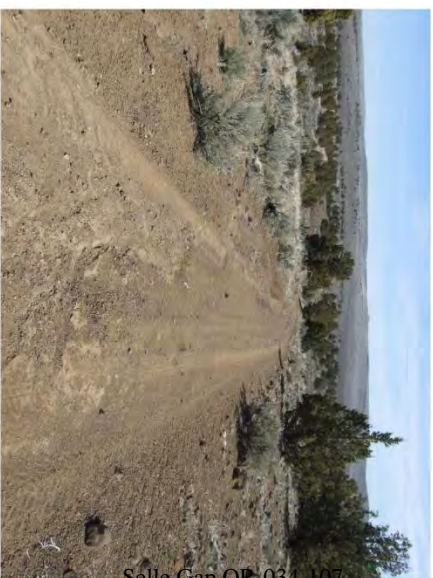
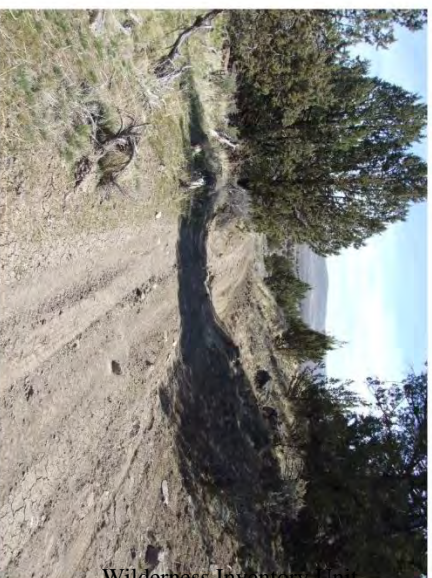
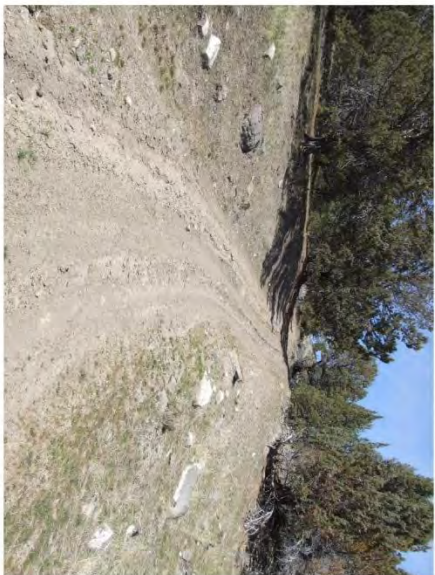
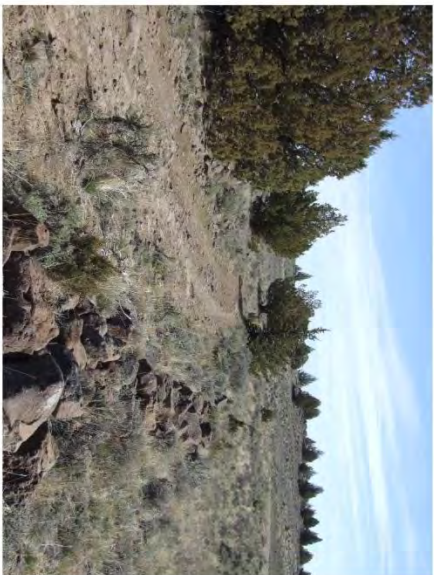
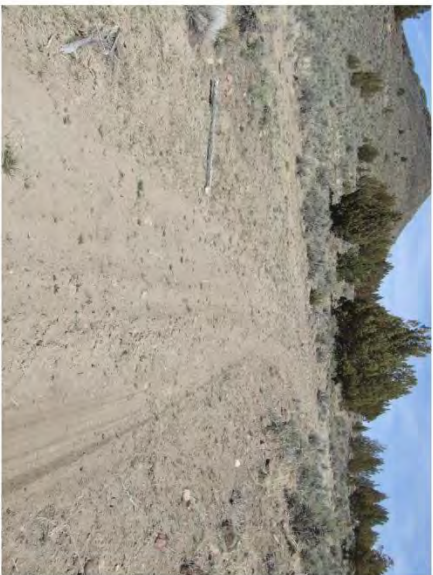
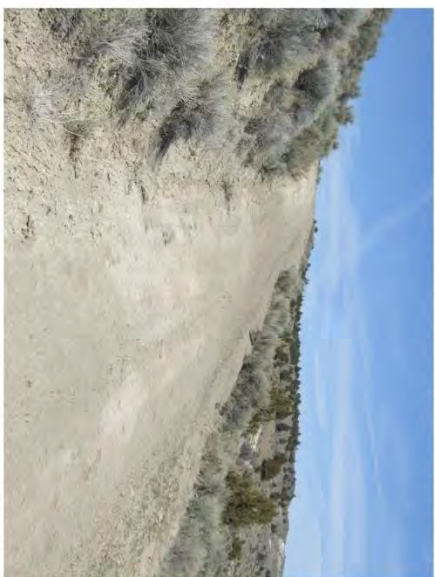
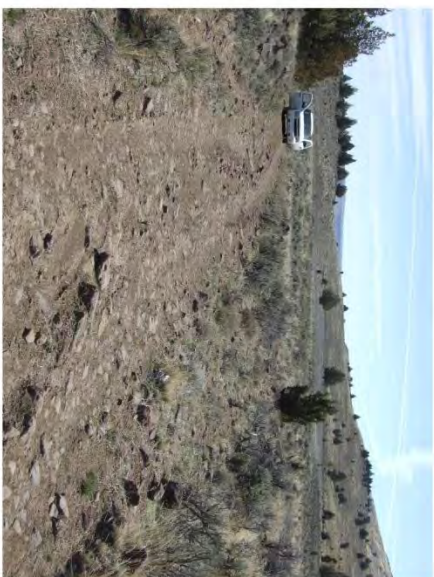
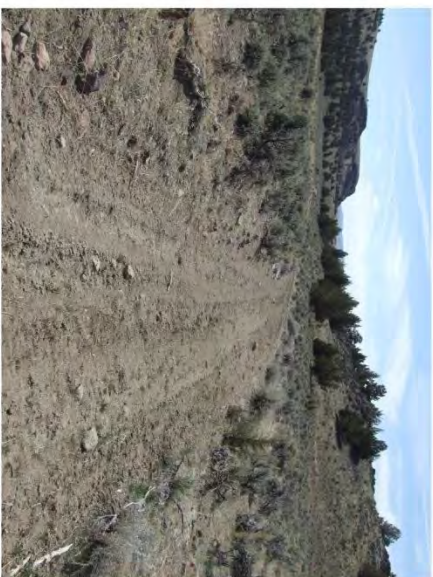
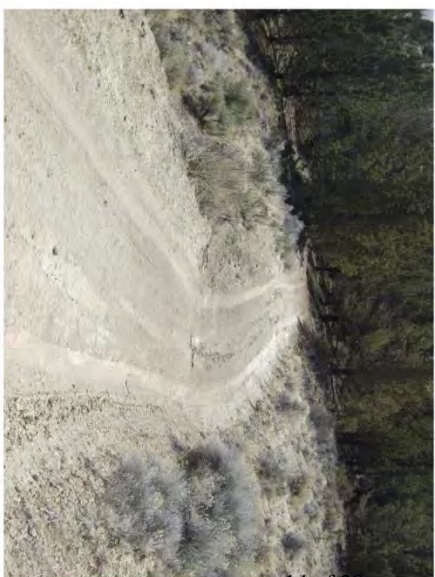
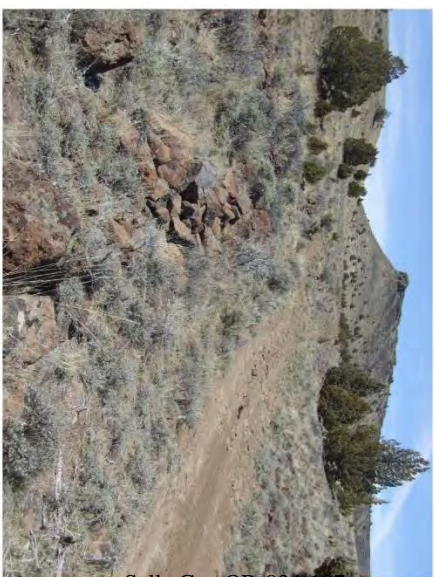
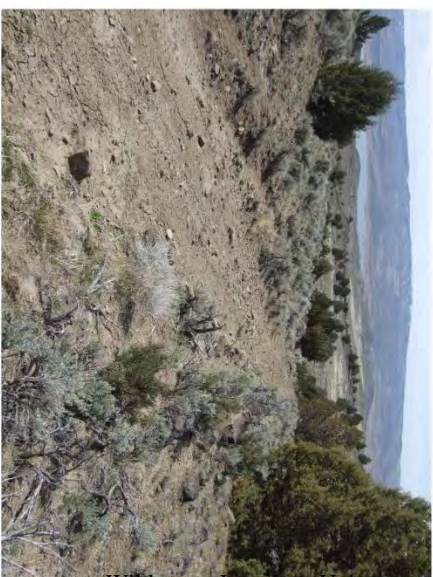
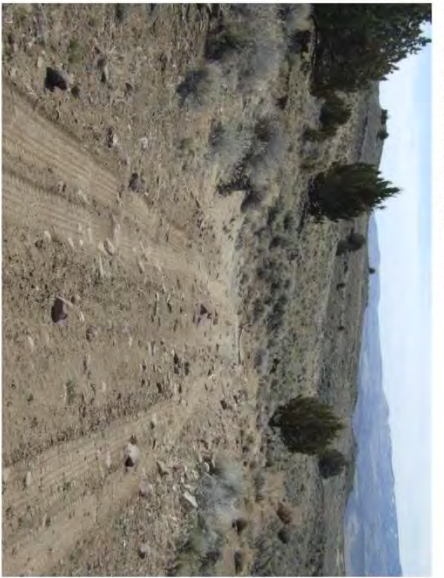
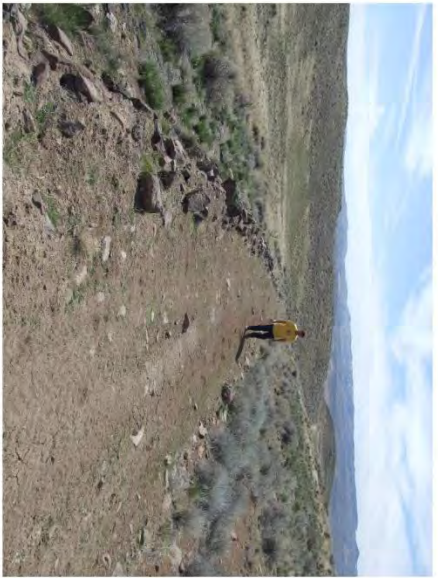
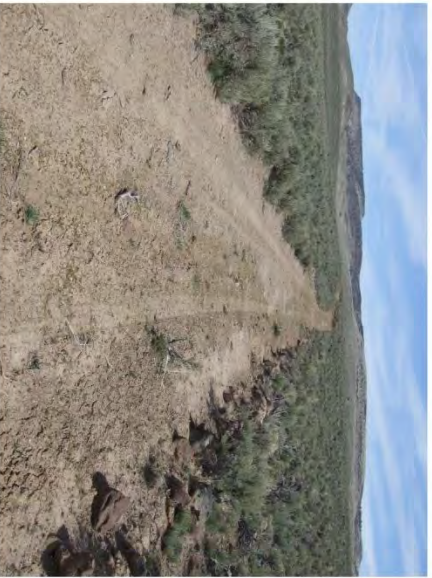
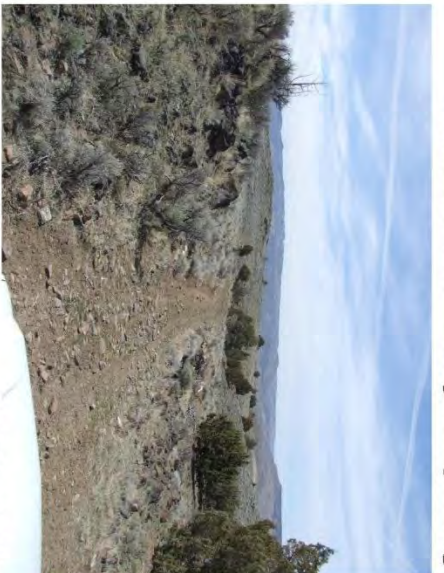
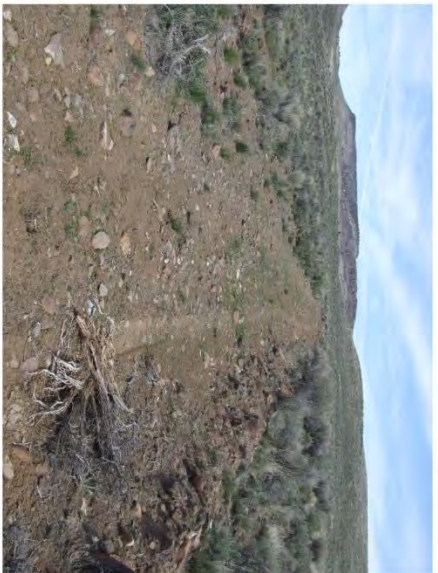
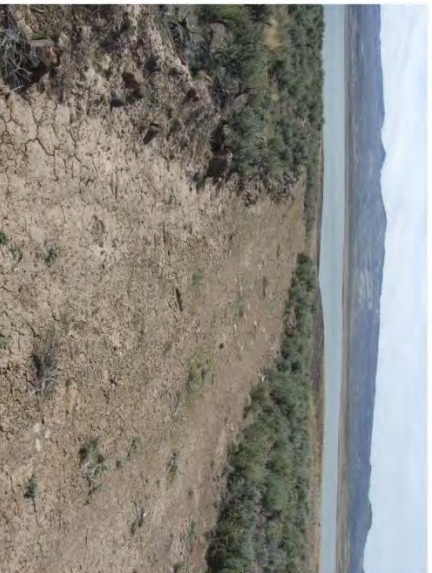
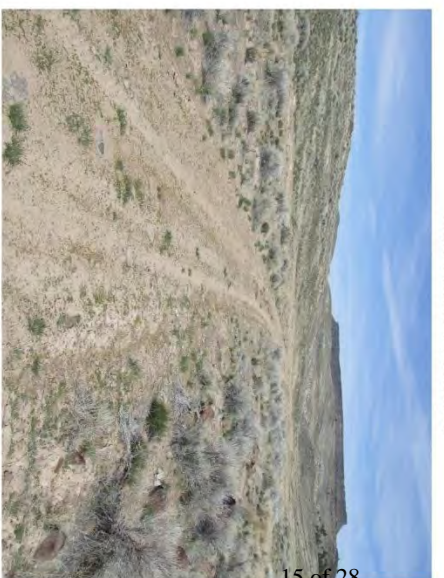
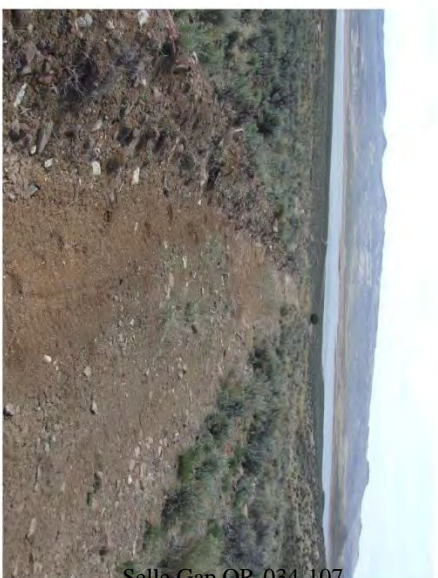
**Describe:** Drainage ditches are apparent along sections of the route.

**Explain:** Much of this route was very recently graded and drainage ditches worked to remove water runoff from its traveling surface. The sage brush associated with the route's berms and drainage ditches appears to have only recently been mechanically manipulated. Additionally, there remains visual evidence of the grader used for mechanical maintenance of the route.

Visual evidence of recent vehicle passes observed. Also, visual evidence of recent tracks of heavy equipment likely due mechanical maintenance performed on the route.

**Explanation:** Route meets the criteria for a road, as described and explained above.

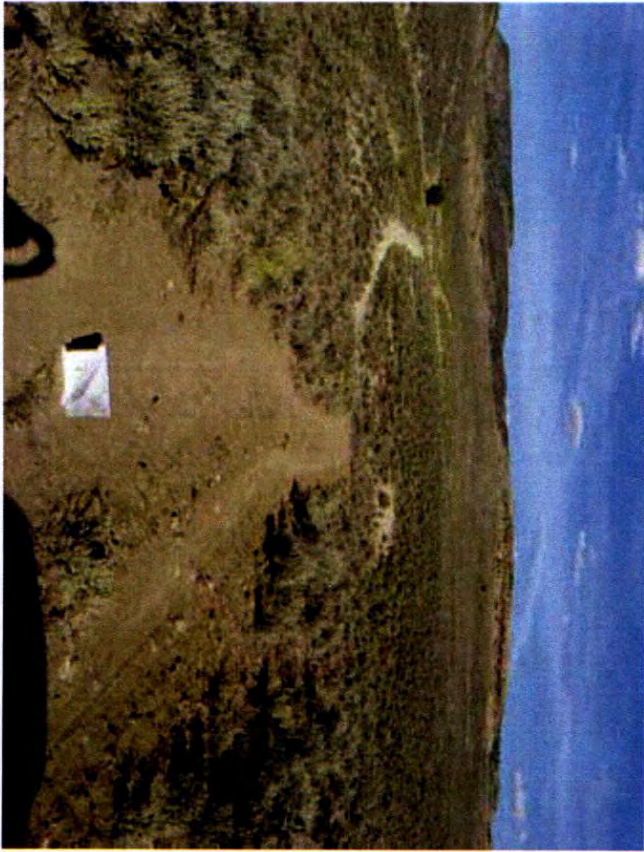
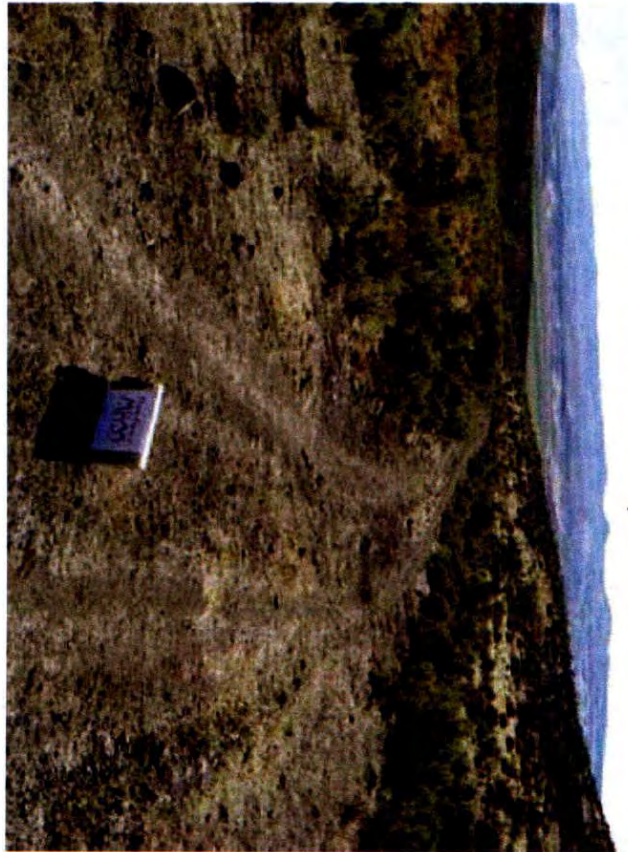
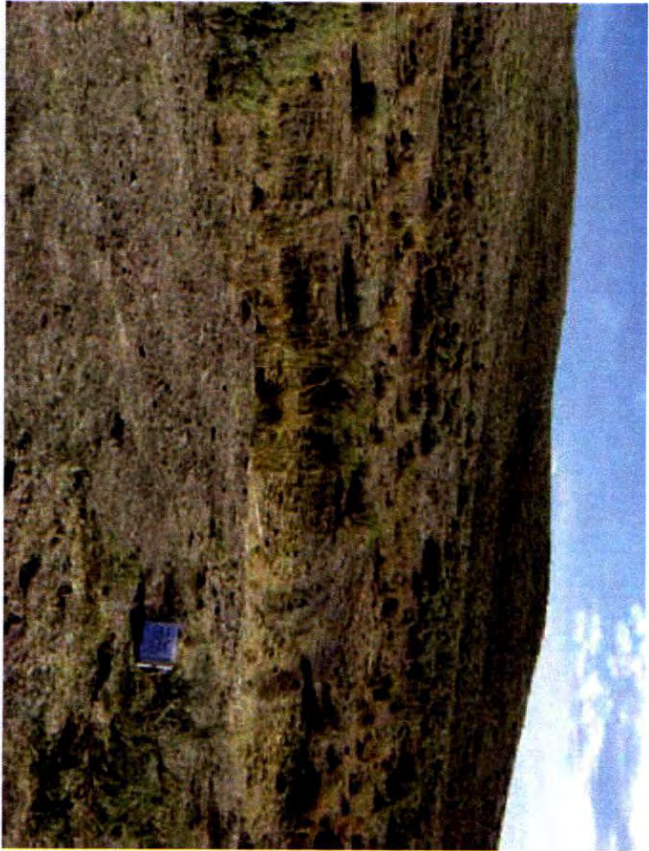
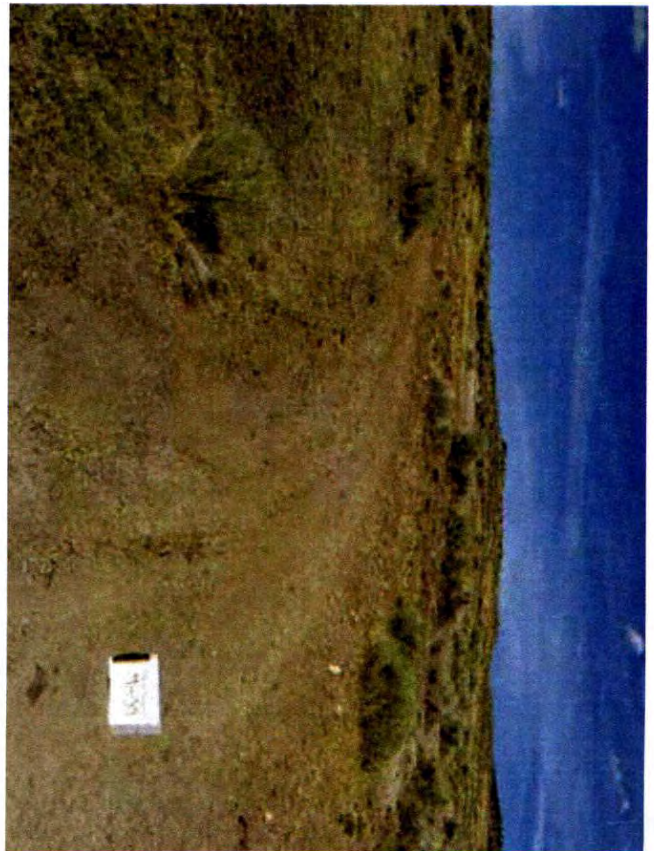
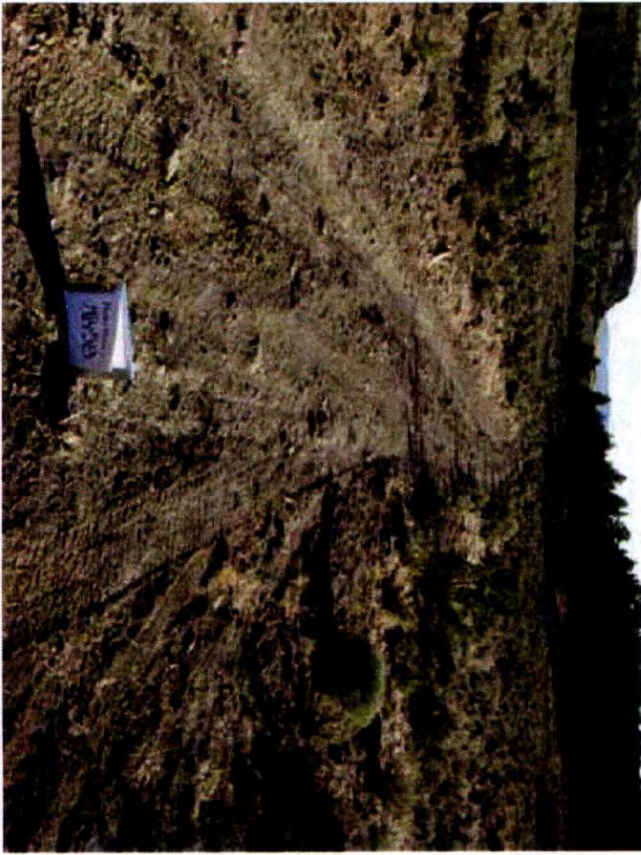
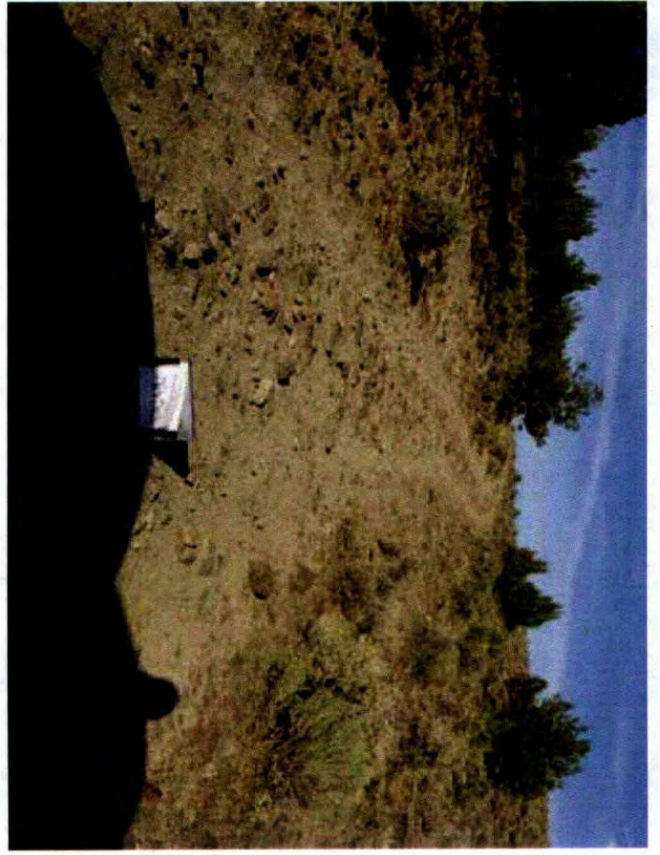
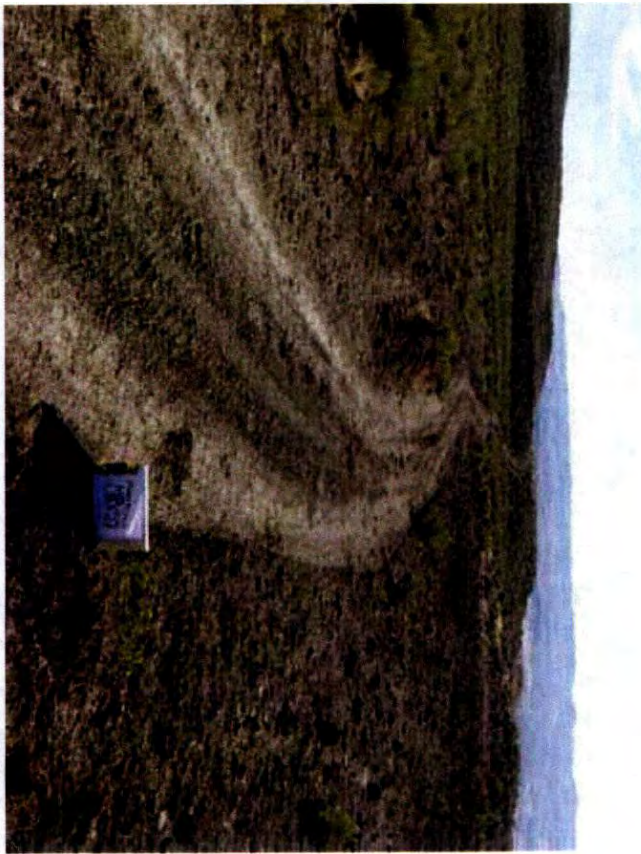
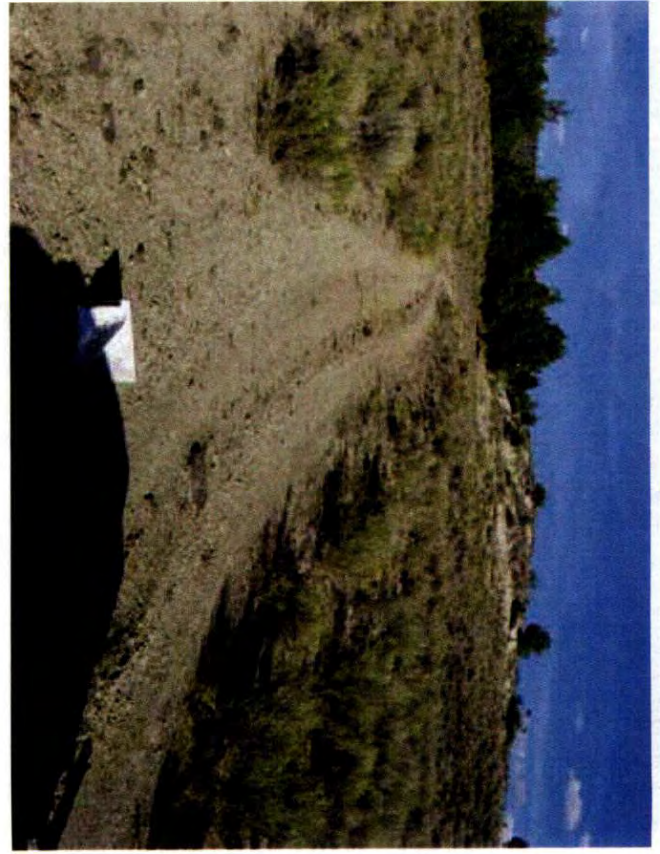
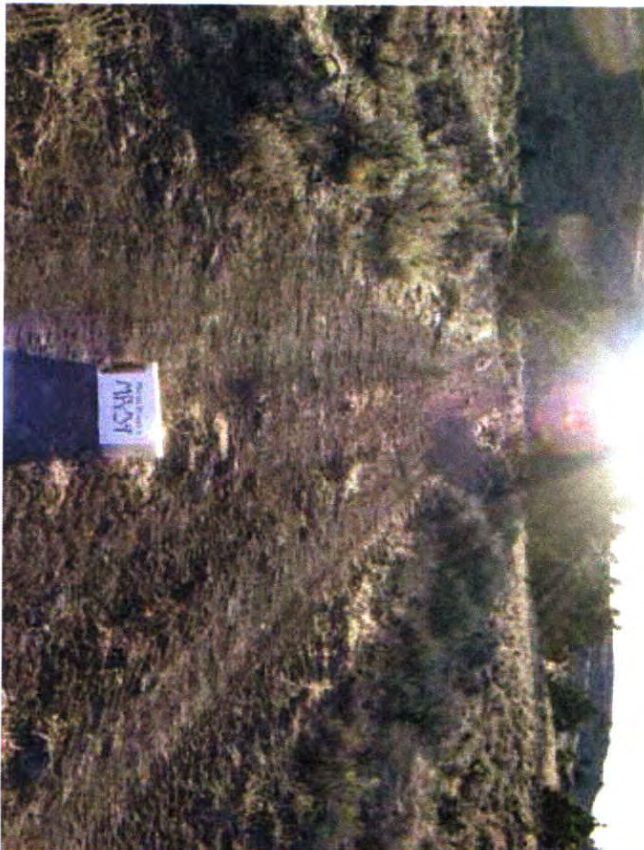
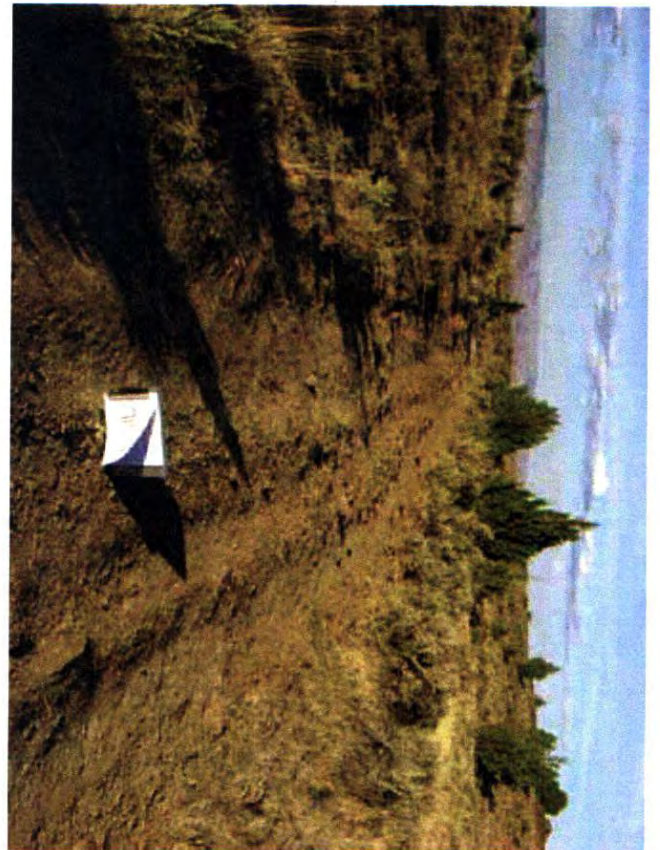
OR-034-107 Selley Gap ~ Burns District 4/2010 Photo Point - "Unknown 12" route

Describe evidence (vehicle tracks observed) and other rationale for whether use has occurred or will continue to occur on a relatively regular basis. Multiple sets of vehicle tracks in roadway → minimal vegetation in roadway suggest regular use.

Specific date of photos is not known, other than they were taken by Burns District BLM during 2009.
