Wilderness Inventory Unit Index of Documents
Stemler Ridge OR-034-010, 21 total pages

Year: 2010 Unit Number/Name: OR-034-010 — Stemler Ridge

FORM 2 -- DOCUMENTATION OF CURRENT WILDERNESS INVENTORY CONDITIONS

Wilderness Inventory Unit Name/Number: OR-034-010 – Stemler Ridge

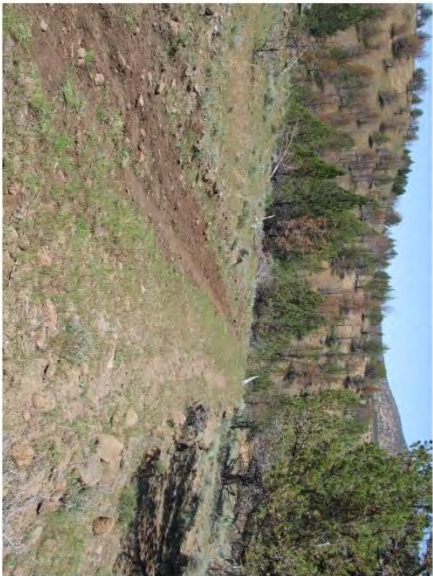
034-RT66-A-NW.JPG

034-RT66-A	NW	Route	20090624	Side cut.
034-RT66-B	S	Route	20090624	Rocky berm. Side cut.
034-RT66-B	N	Route	20090624	Rocky berm. Side cut.
034-RT66-C	SE	Route	20090624	Rocky berm. Side cut.
034-RT66-C	NW	Route	20090624	Rocky berm. Side cut.
034-RT66-D	SE	Route	20090624	Rocky berm. Side cut.
034-RT66-D	NW	Route	20090624	Rocky berm. Side cut.
