Wilderness Inventory Unit Index of Documents
Twin Butte OR-036-002, 32 total pages

Year: 2007 Inventory Unit Name/Number: Twin Butte OR-036-002

FORM 2**DOCUMENTATION OF CURRENT WILDERNESS INVENTORY CONDITIONS:****Inventory Unit Name/Number: Twin Butte OR-036-002**

Route Name and/or Identifier: BLM Road River Spur/6354-0-A0; Oregon Butte proposed WSA Addition WO13c, WO19a, WO19b

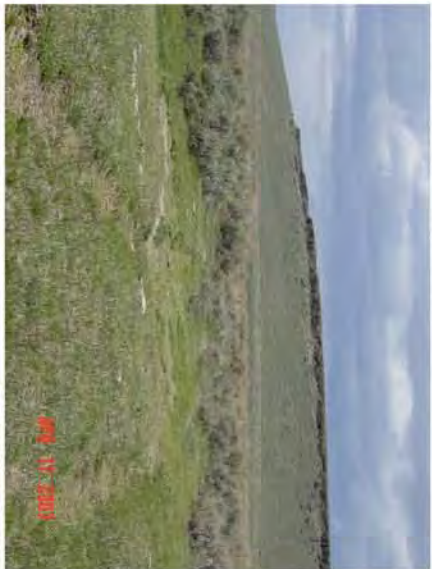
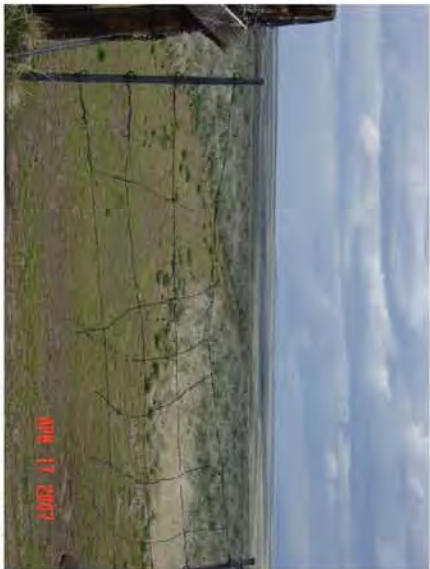
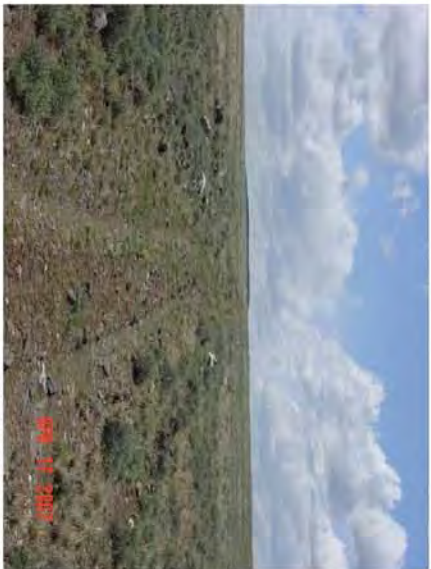
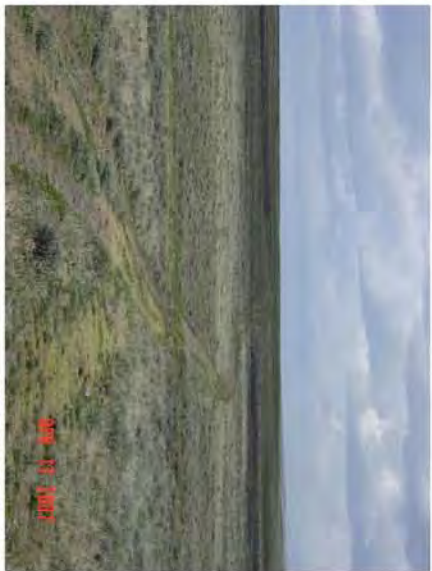
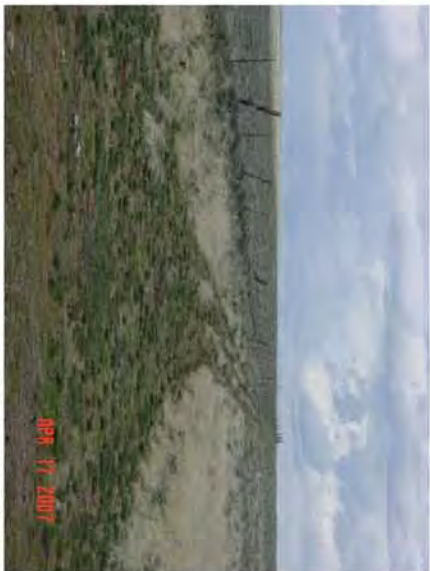
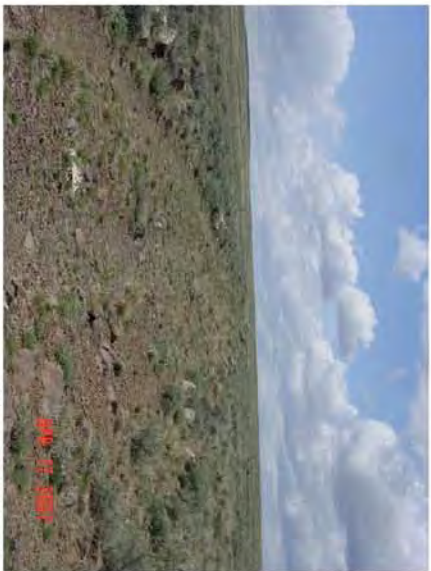
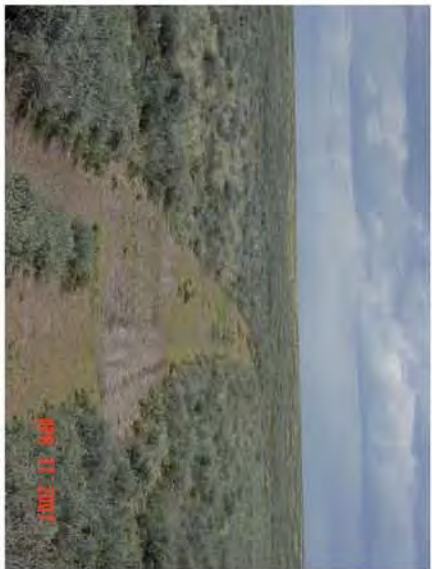
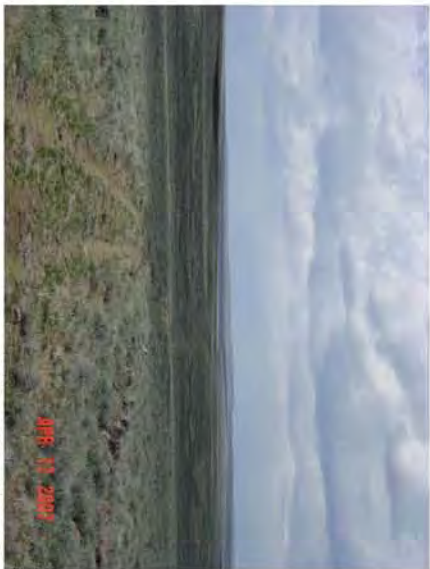
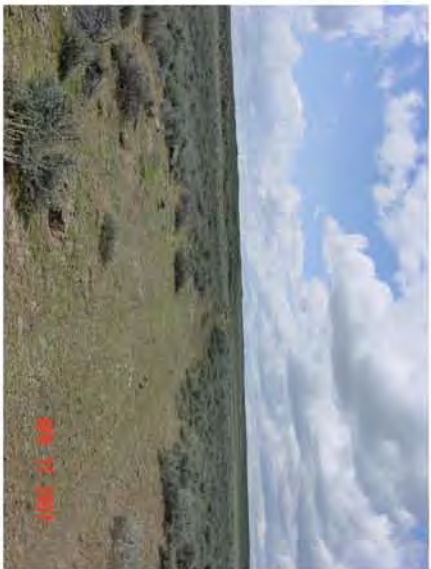
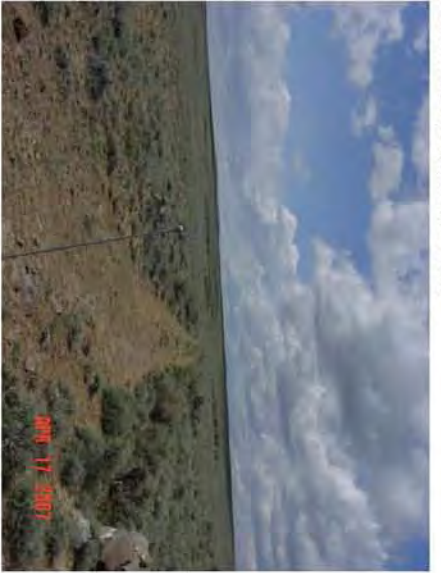
Explain: Recent maintenance to BLM Road 6354-0-00 is not evident. All photographs show that earthen berms on the edge of the road presently contain some brush encroaching from undisturbed areas outside of the roadbed. Some pictures also show small discontinuous quantities of brush in the center of the roadbed between wheel tracks. Although it has been many years since maintenance was performed on this road, it is evident by the condition of the roadbed in BLM and ONDA photographs that little, if any, maintenance is needed to keep the roadbed in good operational condition. This is consistent with Best Management Practices BLM has incorporated into the Southeastern Oregon Resource Management Plan for Vale District.

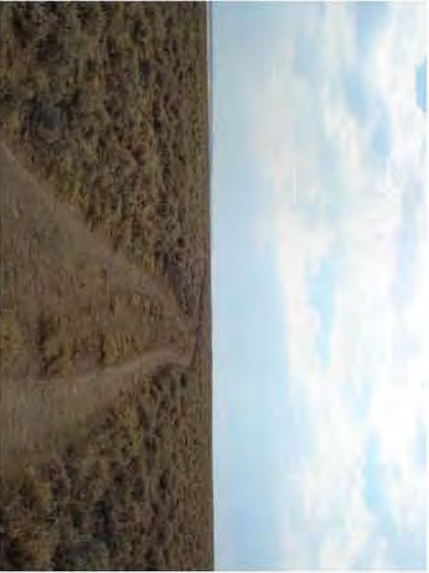
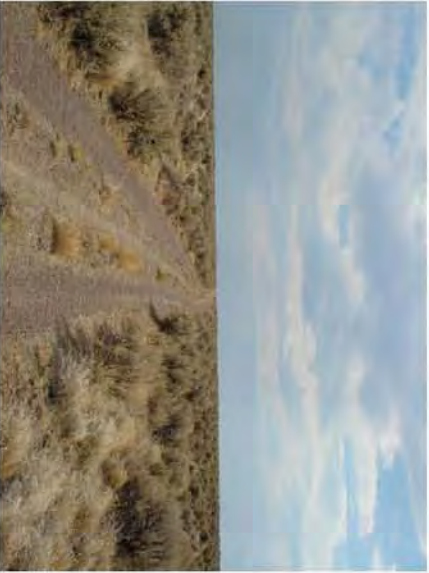
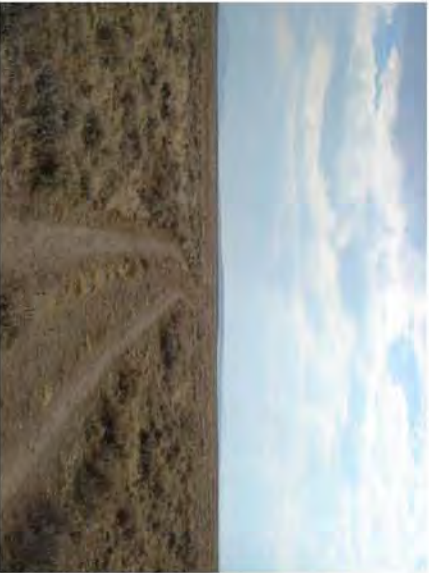
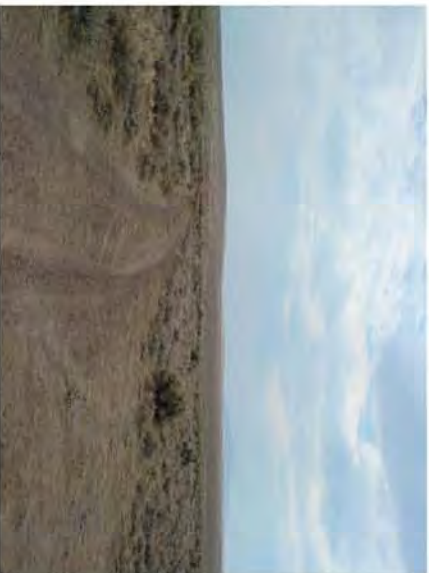
All photographs covering BLM road 6354-0-A0 listed in Section I, except WA143, show a well-traveled and compacted roadbed. As stated previously, over time vegetation has become established within the berms along each side of the roadbed but it does not restrict travel on this road. Low-growing vegetation is also present in rocky areas of the roadbed and gives the appearance that the road is not often traveled. A large percentage of this vegetation can be attributed to annual species that flourish in the spring and die off or are beaten down by traffic over the active use period during late spring, and throughout the year into late fall. Most of the remaining series of photographs along BLM road 6354-0-00, both for ONDA and BLM, show variations of the rocky and natural soil roadbed.

Explain: Recent maintenance for BLM road 6354-0-A0 is not evident. Any remnants of earthen berms left from original construction are shown in photographs referenced by BLM or ONDA to presently contain brush encroaching from the undisturbed areas outside of the roadbed. These photographs also show some areas that contain intermittent lines of brush in the center of the roadbed between wheel tracks. Although it has been many years since maintenance has been performed on this road, it is evident that little if any maintenance is needed to keep the roadbed in good operational condition. This is consistent with the Best Management Practices BLM has incorporated into the Southeastern Oregon Resource Management Plan for Vale District.

BLM road 6354-0-A0 has annual use as evidenced by the lack of brush in most sections of the road and by well-used bare ground where vehicle tires track, as shown in photographs by both BLM and ONDA. The road is well traveled, wide along most of its length, and is clearly defined on the landscape. The road is also used on a seasonal basis by hunters, recreation enthusiasts, and as access to private inholdings for livestock management.
