Alaska
2021: Annual Manager's Report

Steese

National Conservation Area

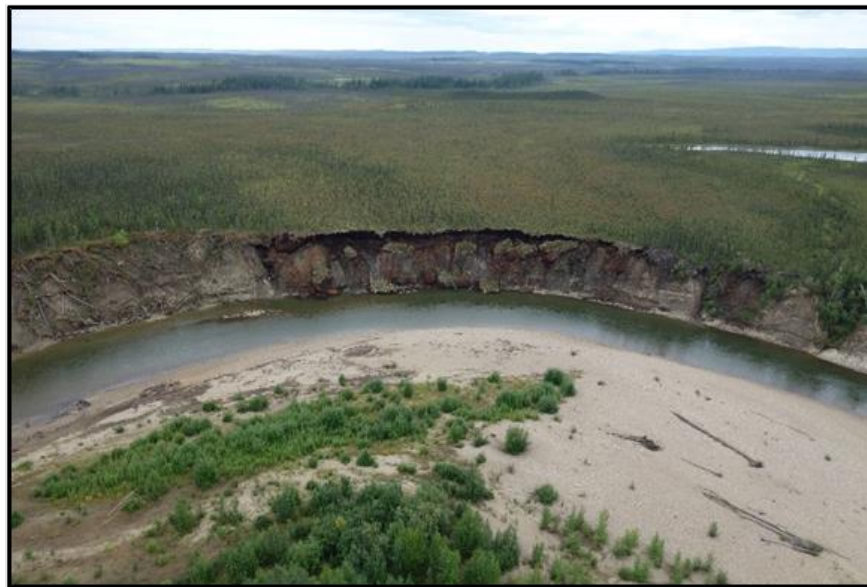
Figure 4. View of a river bend with permafrost melting causing the bank to slough into the river. BLM photo by Robin Mills.

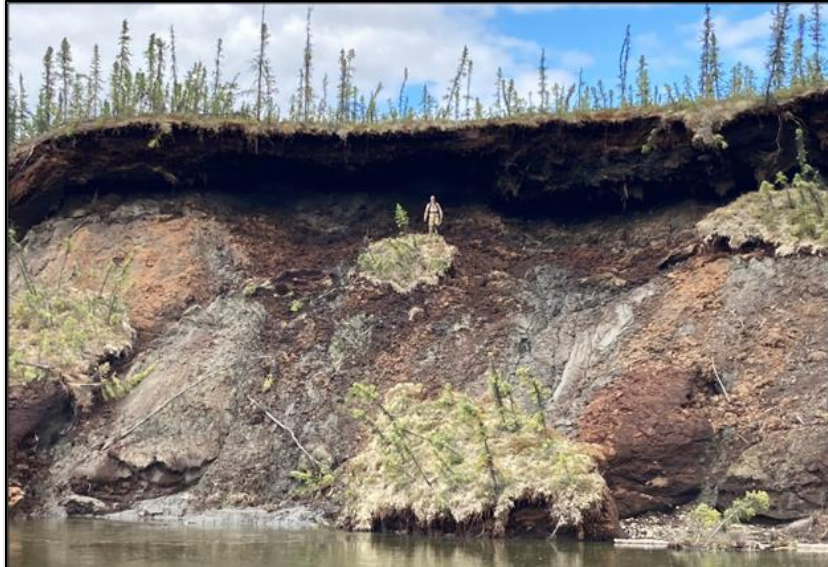
Figure 5. Close up view of stream bank sloughing into the river. Photo used with permission by Nancy Bigelow, University of Alaska Fairbanks.

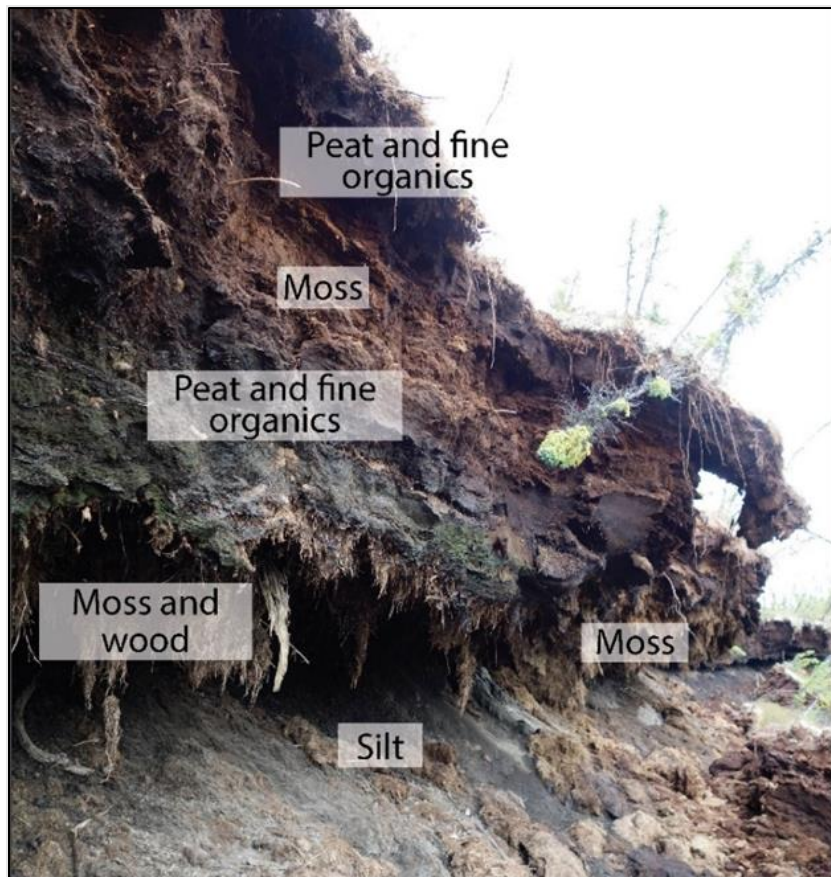
Figure 6. Close up view of bank with a description of different soil horizons. From top to bottom peat and fine organics, moss, peat and fine organics, moss and wood, moss and silt. BLM photo by Robin Mills.

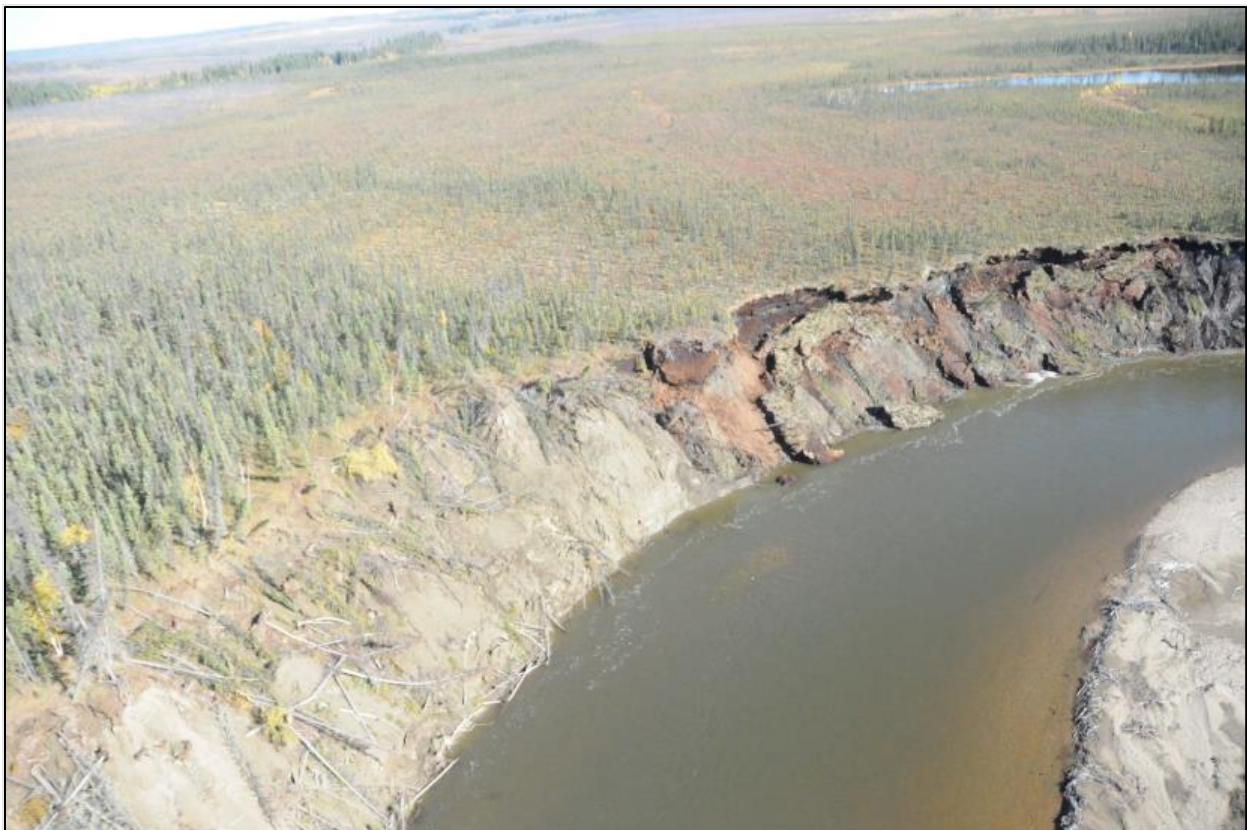
Figure 7. Helicopter flyover photograph of lower Birch Creek Wild and Scenic River showing accelerated erosion of permafrost bank, lower Birch Creek Wild and Scenic River corridor, September 09, 2021. View is upstream. BLM photo by Ben Kennedy.

Increased surface erosion associated with thawing permafrost and melting ground ice results in thermokarst development in low gradient areas and increased thermal erosion on hill slopes. Detachments of seasonally thawed permafrost hill-slope areas and accelerated erosion of ice-rich river embankments are evident in the lower reaches of Birch Creek WSR. Figures 7 through 11.

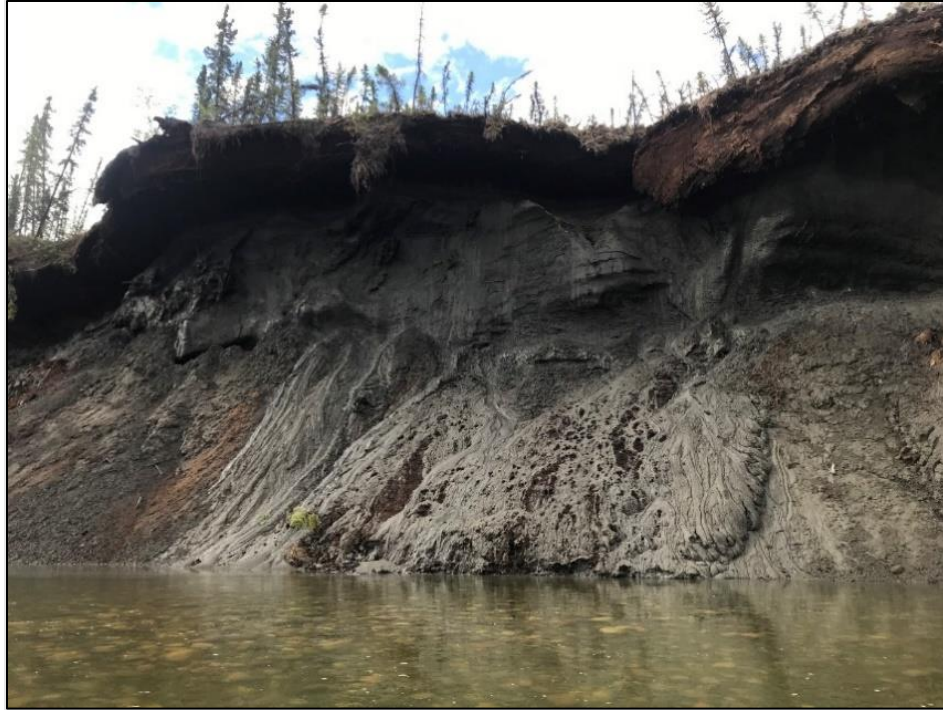
Figure 8. Streamside photograph showing unstable embankment, melting permafrost area, lower Birch Creek Wild and Scenic River. BLM photo by Teri Balsler.

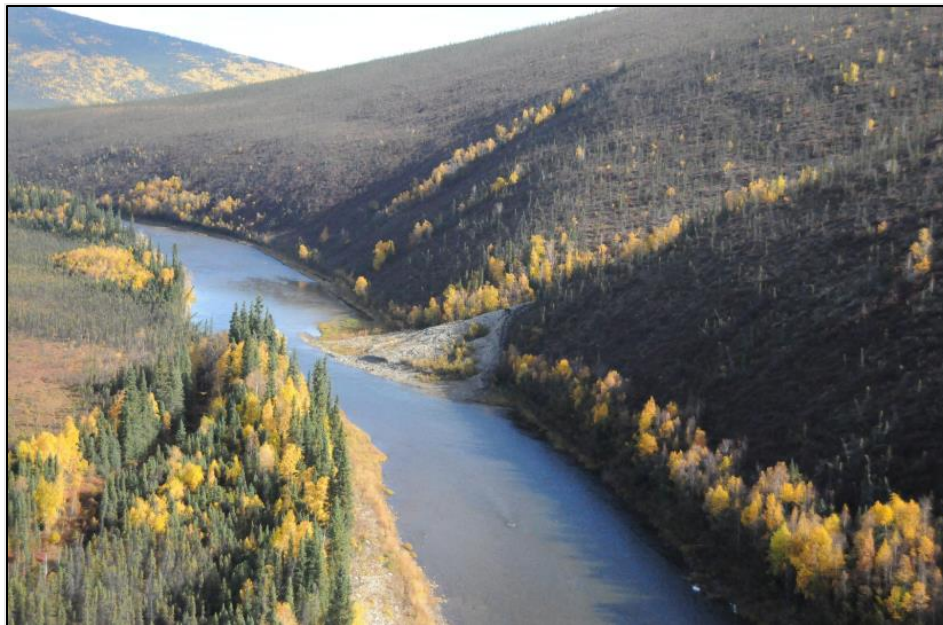
Figure 9. Helicopter flyover photograph of coarse debris alluvial fan, Birch Creek Wild and Scenic River, September 08, 2021. View is downstream. Stressors periodically contributing to Birch Creek turbidity levels include debris slides, active and abandoned placer-mined areas as well as soil instability and erosion associated with wildfires and melting permafrost. BLM photo by Ben Kennedy.

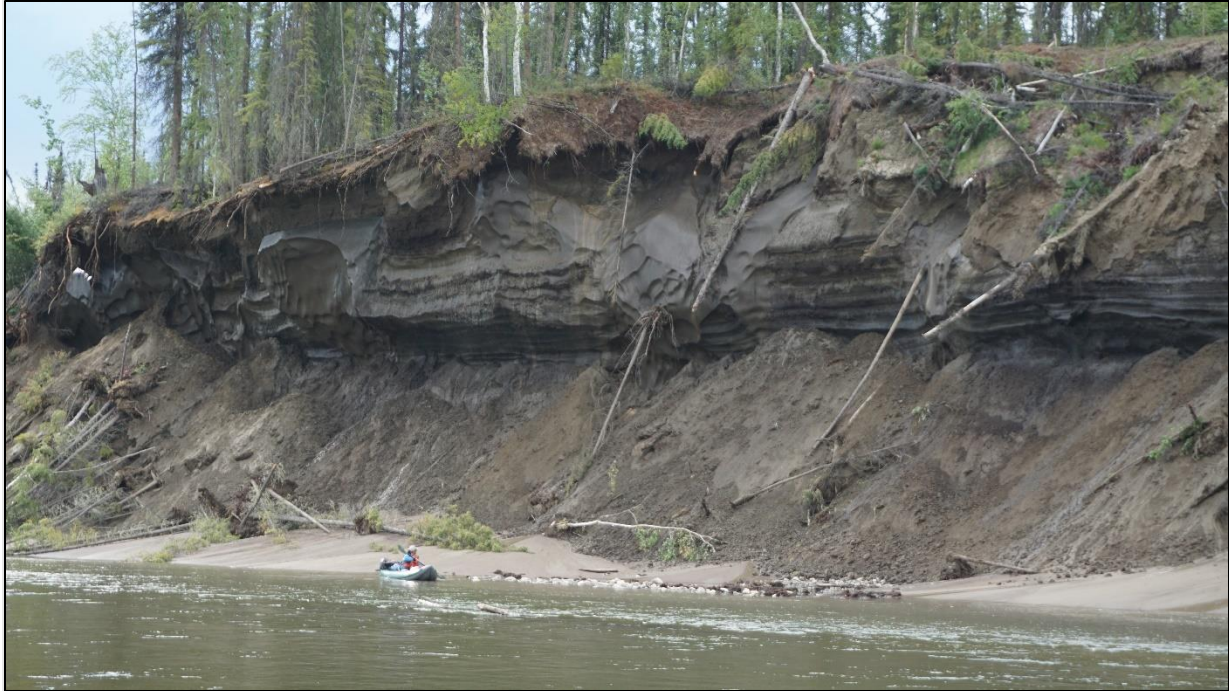
Figure 10. Steese NCA seasonal ranger paddles up for a closer look at the exposed ice lens on Birch Creek Wild and Scenic River. July 2020. BLM photo by Teri Balsler.

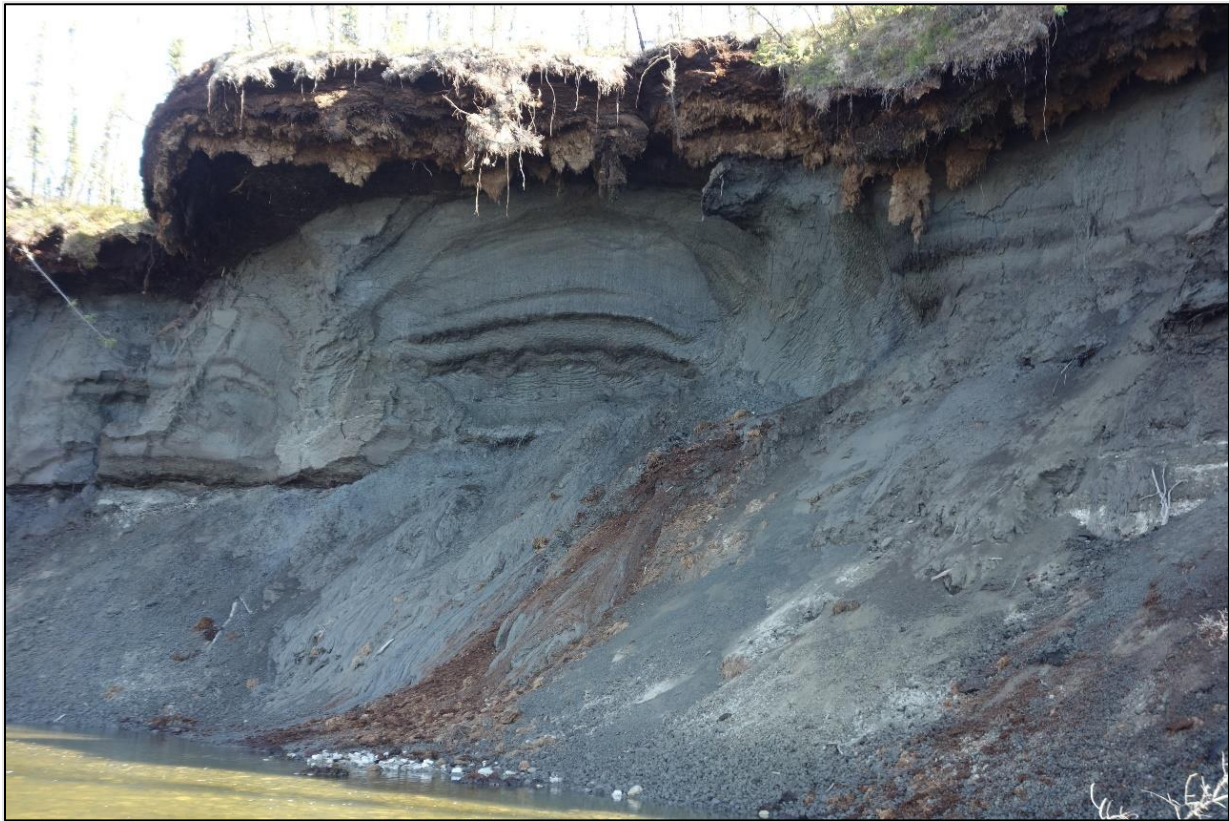
Figure 11. Streamside photograph showing unstable embankment, melting permafrost area, lower Birch Creek Wild and Scenic River, June 2020. BLM photo by Robin Mills, BLM
