RED DEVIL MINE
 Red Devil, Alaska

Figure 3-6
 October 2009
 Surface Water Results

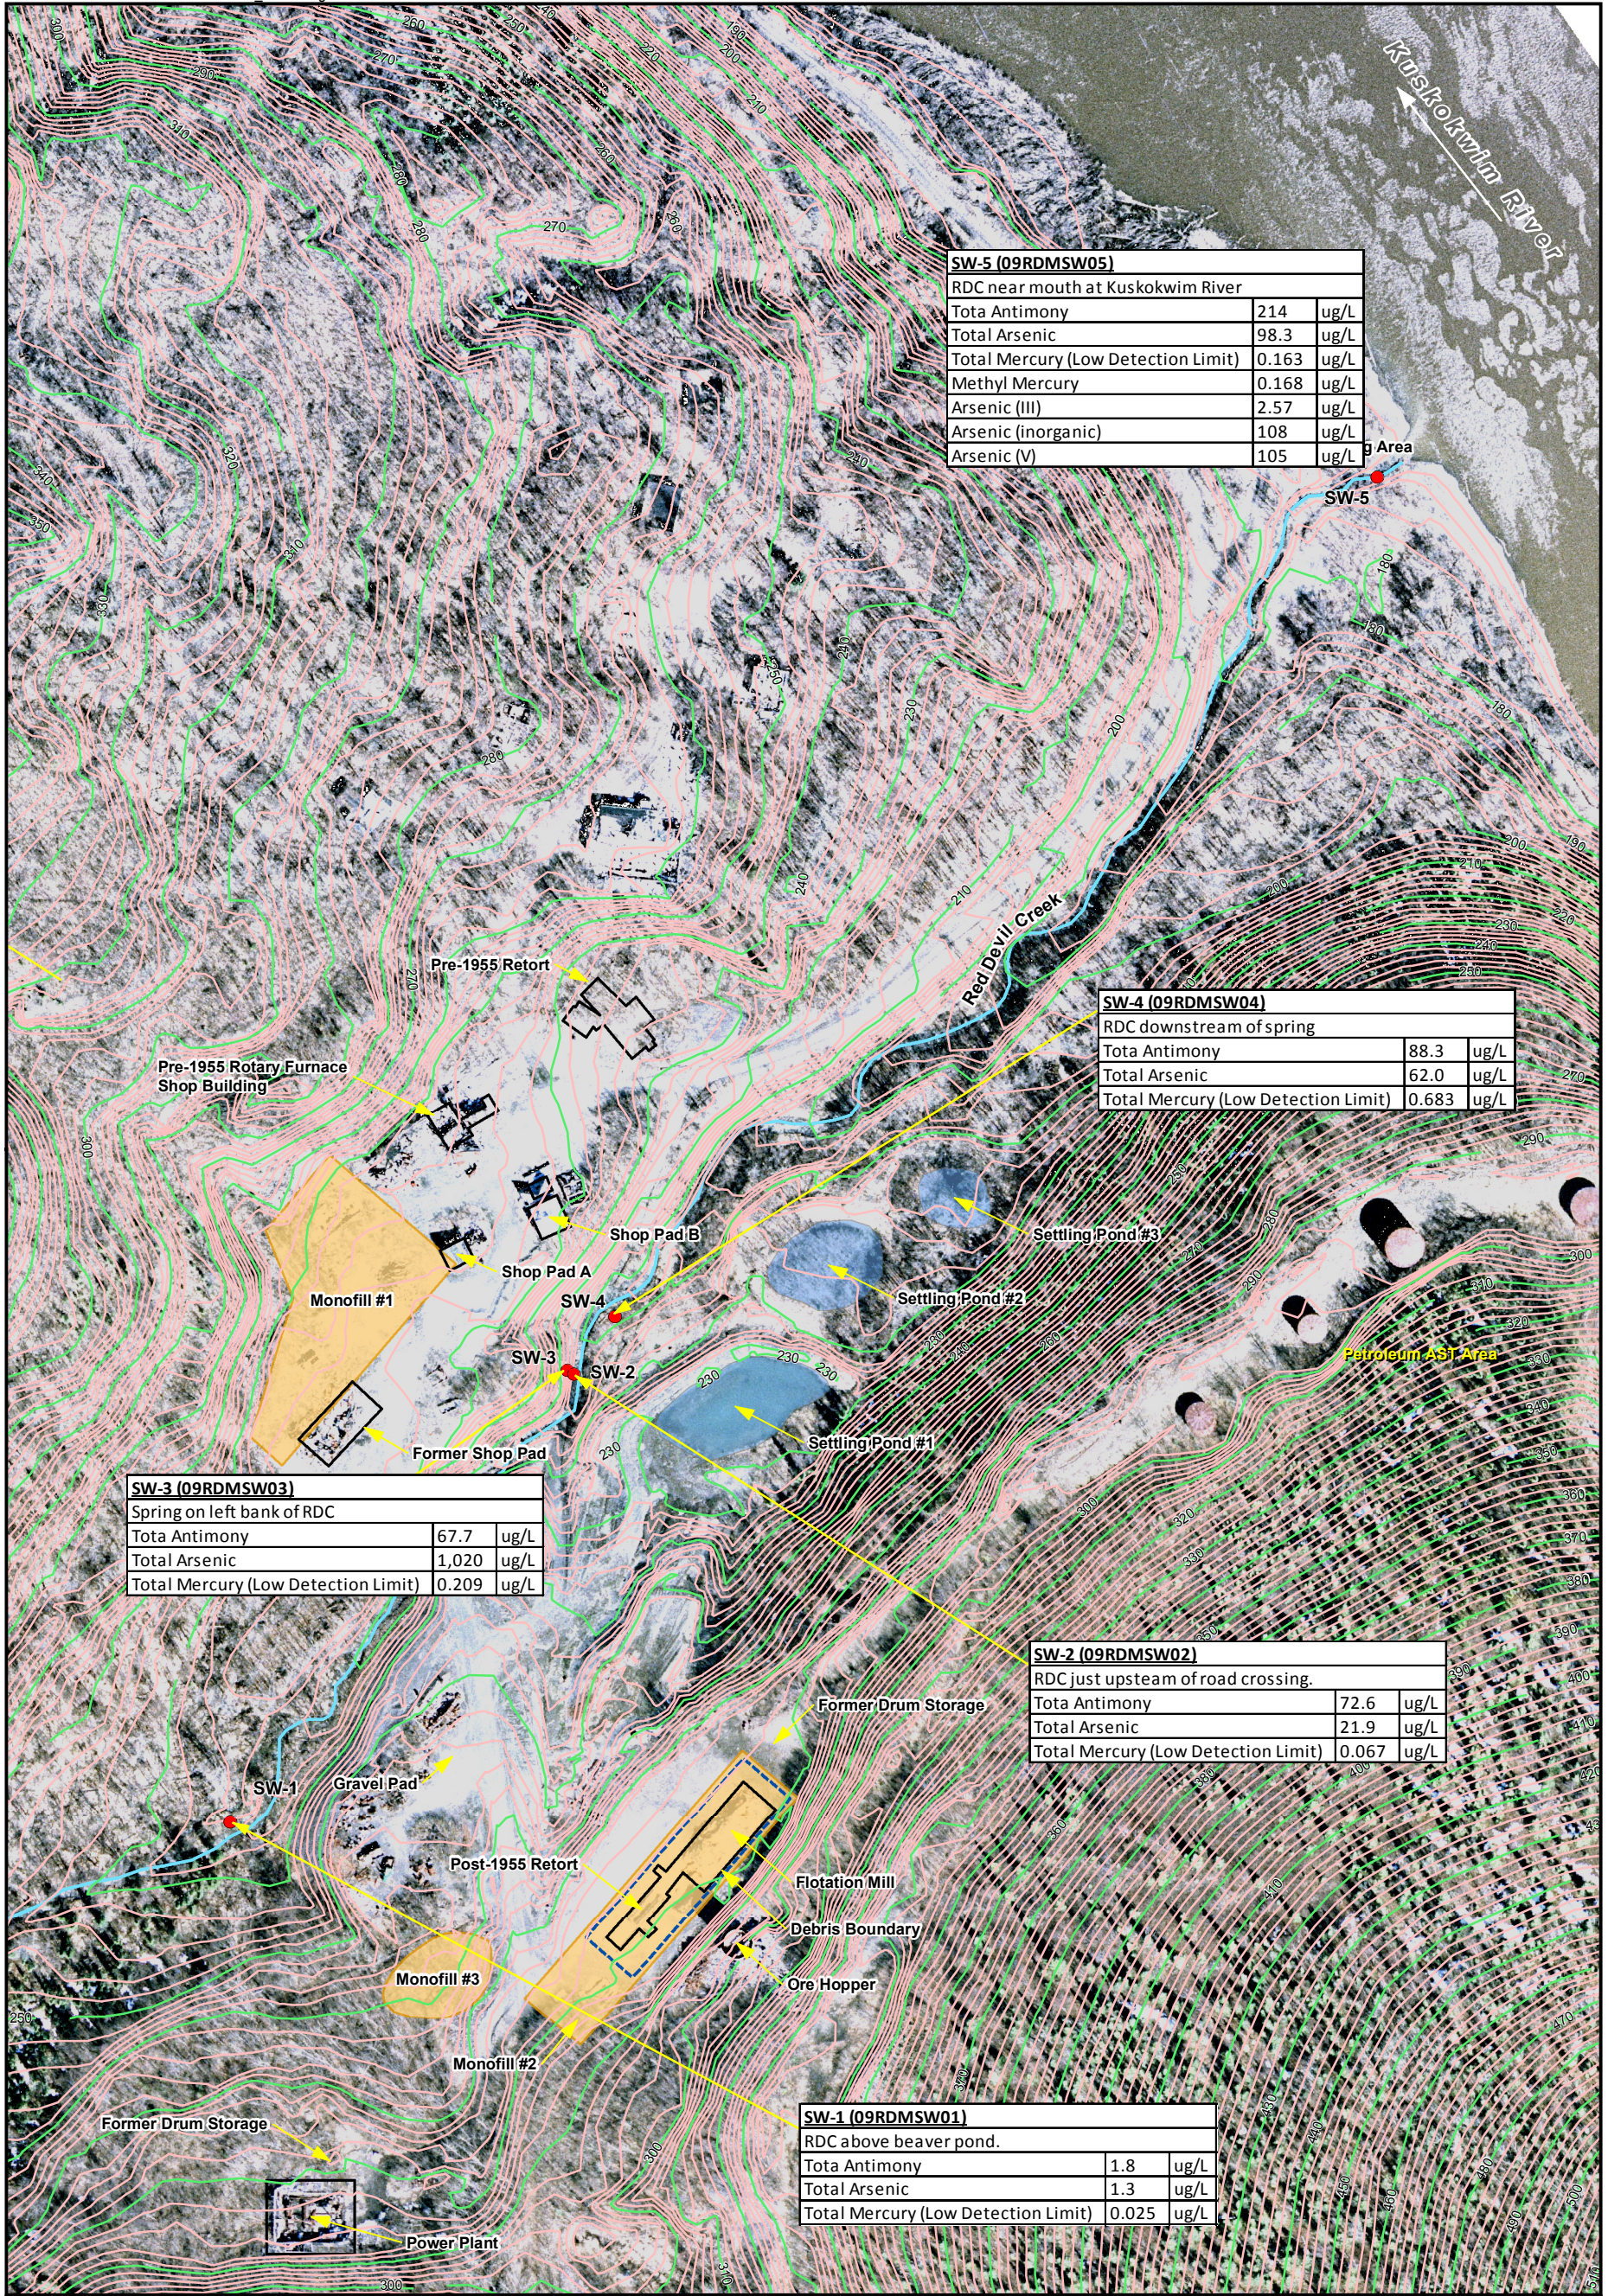
SW-5 (09RDMSW05)		
RDC near mouth at Kuskokwim River		
Total Antimony	214	ug/L
Total Arsenic	98.3	ug/L
Total Mercury (Low Detection Limit)	0.163	ug/L
Methyl Mercury	0.168	ug/L
Arsenic (III)	2.57	ug/L
Arsenic (inorganic)	108	ug/L
Arsenic (V)	105	ug/L

SW-4 (09RDMSW04)		
RDC downstream of spring		
Total Antimony	88.3	ug/L
Total Arsenic	62.0	ug/L
Total Mercury (Low Detection Limit)	0.683	ug/L

SW-3 (09RDMSW03)		
Spring on left bank of RDC		
Total Antimony	67.7	ug/L
Total Arsenic	1,020	ug/L
Total Mercury (Low Detection Limit)	0.209	ug/L

SW-2 (09RDMSW02)		
RDC just upstream of road crossing.		
Total Antimony	72.6	ug/L
Total Arsenic	21.9	ug/L
Total Mercury (Low Detection Limit)	0.067	ug/L

SW-1 (09RDMSW01)		
RDC above beaver pond.		
Total Antimony	1.8	ug/L
Total Arsenic	1.3	ug/L
Total Mercury (Low Detection Limit)	0.025	ug/L
