Remedial Investigation Report

Red Devil Mine, Alaska

March 2012

Prepared by:
ECOLOGY AND ENVIRONMENT, INC.
720 3rd Avenue, Suite 17
Seattle, WA 98104-1816

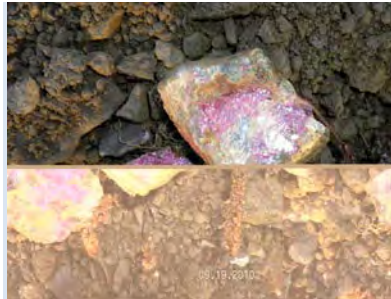
Cinnabar from Red Devil Mine

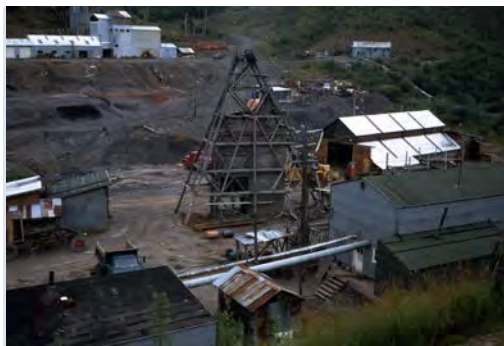
The Pre-1955 Main Processing Area, showing headworks and support buildings. The post-1955 mill is in the background.

In 1941, the New Idria Quicksilver Mining Company installed a 40-ton rotary kiln (Wright and Rutledge 1947). In 1943, the New Idria-Alaska Quicksilver Mining Co. installed modern equipment for furnacing and retorting the Red Devil ore. The reduction plant was equipped with a 50-ton fine ore bin, a 12-ton burned ore bin, a 36-inch by 40-foot rotary kiln, Sirocco dust collectors, a fan, condensers, and redwood tanks. A jaw crusher reduced the ore to less than 2 inches (Webber et.al. 1947). Wood was used for furnace fuel from 1943 to 1946. In 1947, the furnace was equipped with a burner, and diesel oil was used thereafter (Wright and Rutledge 1947). It is assumed that this rotary kiln was installed in the structures labeled “Pre-1955 Rotary Furnace building” in Figure 1-3. The term “Pre-1955 Rotary Furnace” is retained for the purpose of this report to maintain consistency with previous reports.

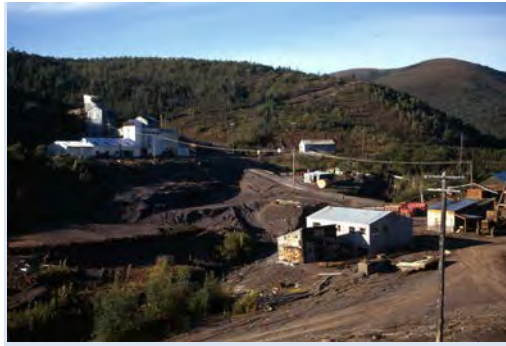
The Main Processing Area in 1969, showing the flotation mill added to the post-1955 mill building, and the settling ponds.

Some time after production resumed in 1969, a flotation mill was installed within an addition to the northern end of the Post-1955 Retort building to produce cinnabar and stibnite concentrates. A ball mill was used to mill the ore, and various chemicals, including “pine oil,” lead acetate, and Dowfroth 250, were used as flotation agents. Tailings from the flotation unit were sluiced from the flotation mill into the three settling ponds via a wooden chute (TNH 1987).

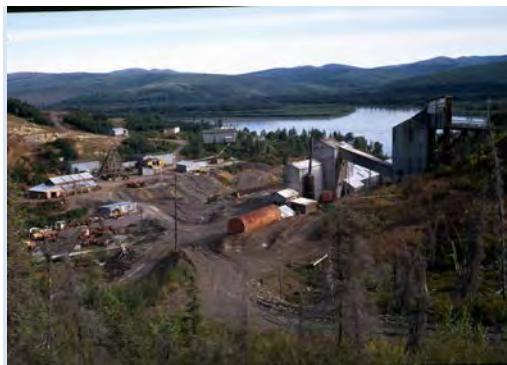
Overview of the Main Processing Area in 1969 or 1970 from the southeast.

From 1969 through 1971, a flotation mill was operated at the site to process ore into cinnabar and stibnite concentrates for shipment to Japan. The resulting flotation tailings consist of the fraction of milled ore remaining after selected ore minerals are separated from the bulk ore slurry using water and flotation agents. These flotation tailings were discharged into the settling ponds north of the Post-1955 Retort building area. Various flotation agents, including pine oil and Dowfroth 250 (frothers and flotation agents), lead acetate (activator for stibnite), and other chemicals may have been used as part of the flotation process (BLM 2009). Although these materials were likely recycled to some extent, some quantities of the flotation agents potentially were discharged to the settling ponds.

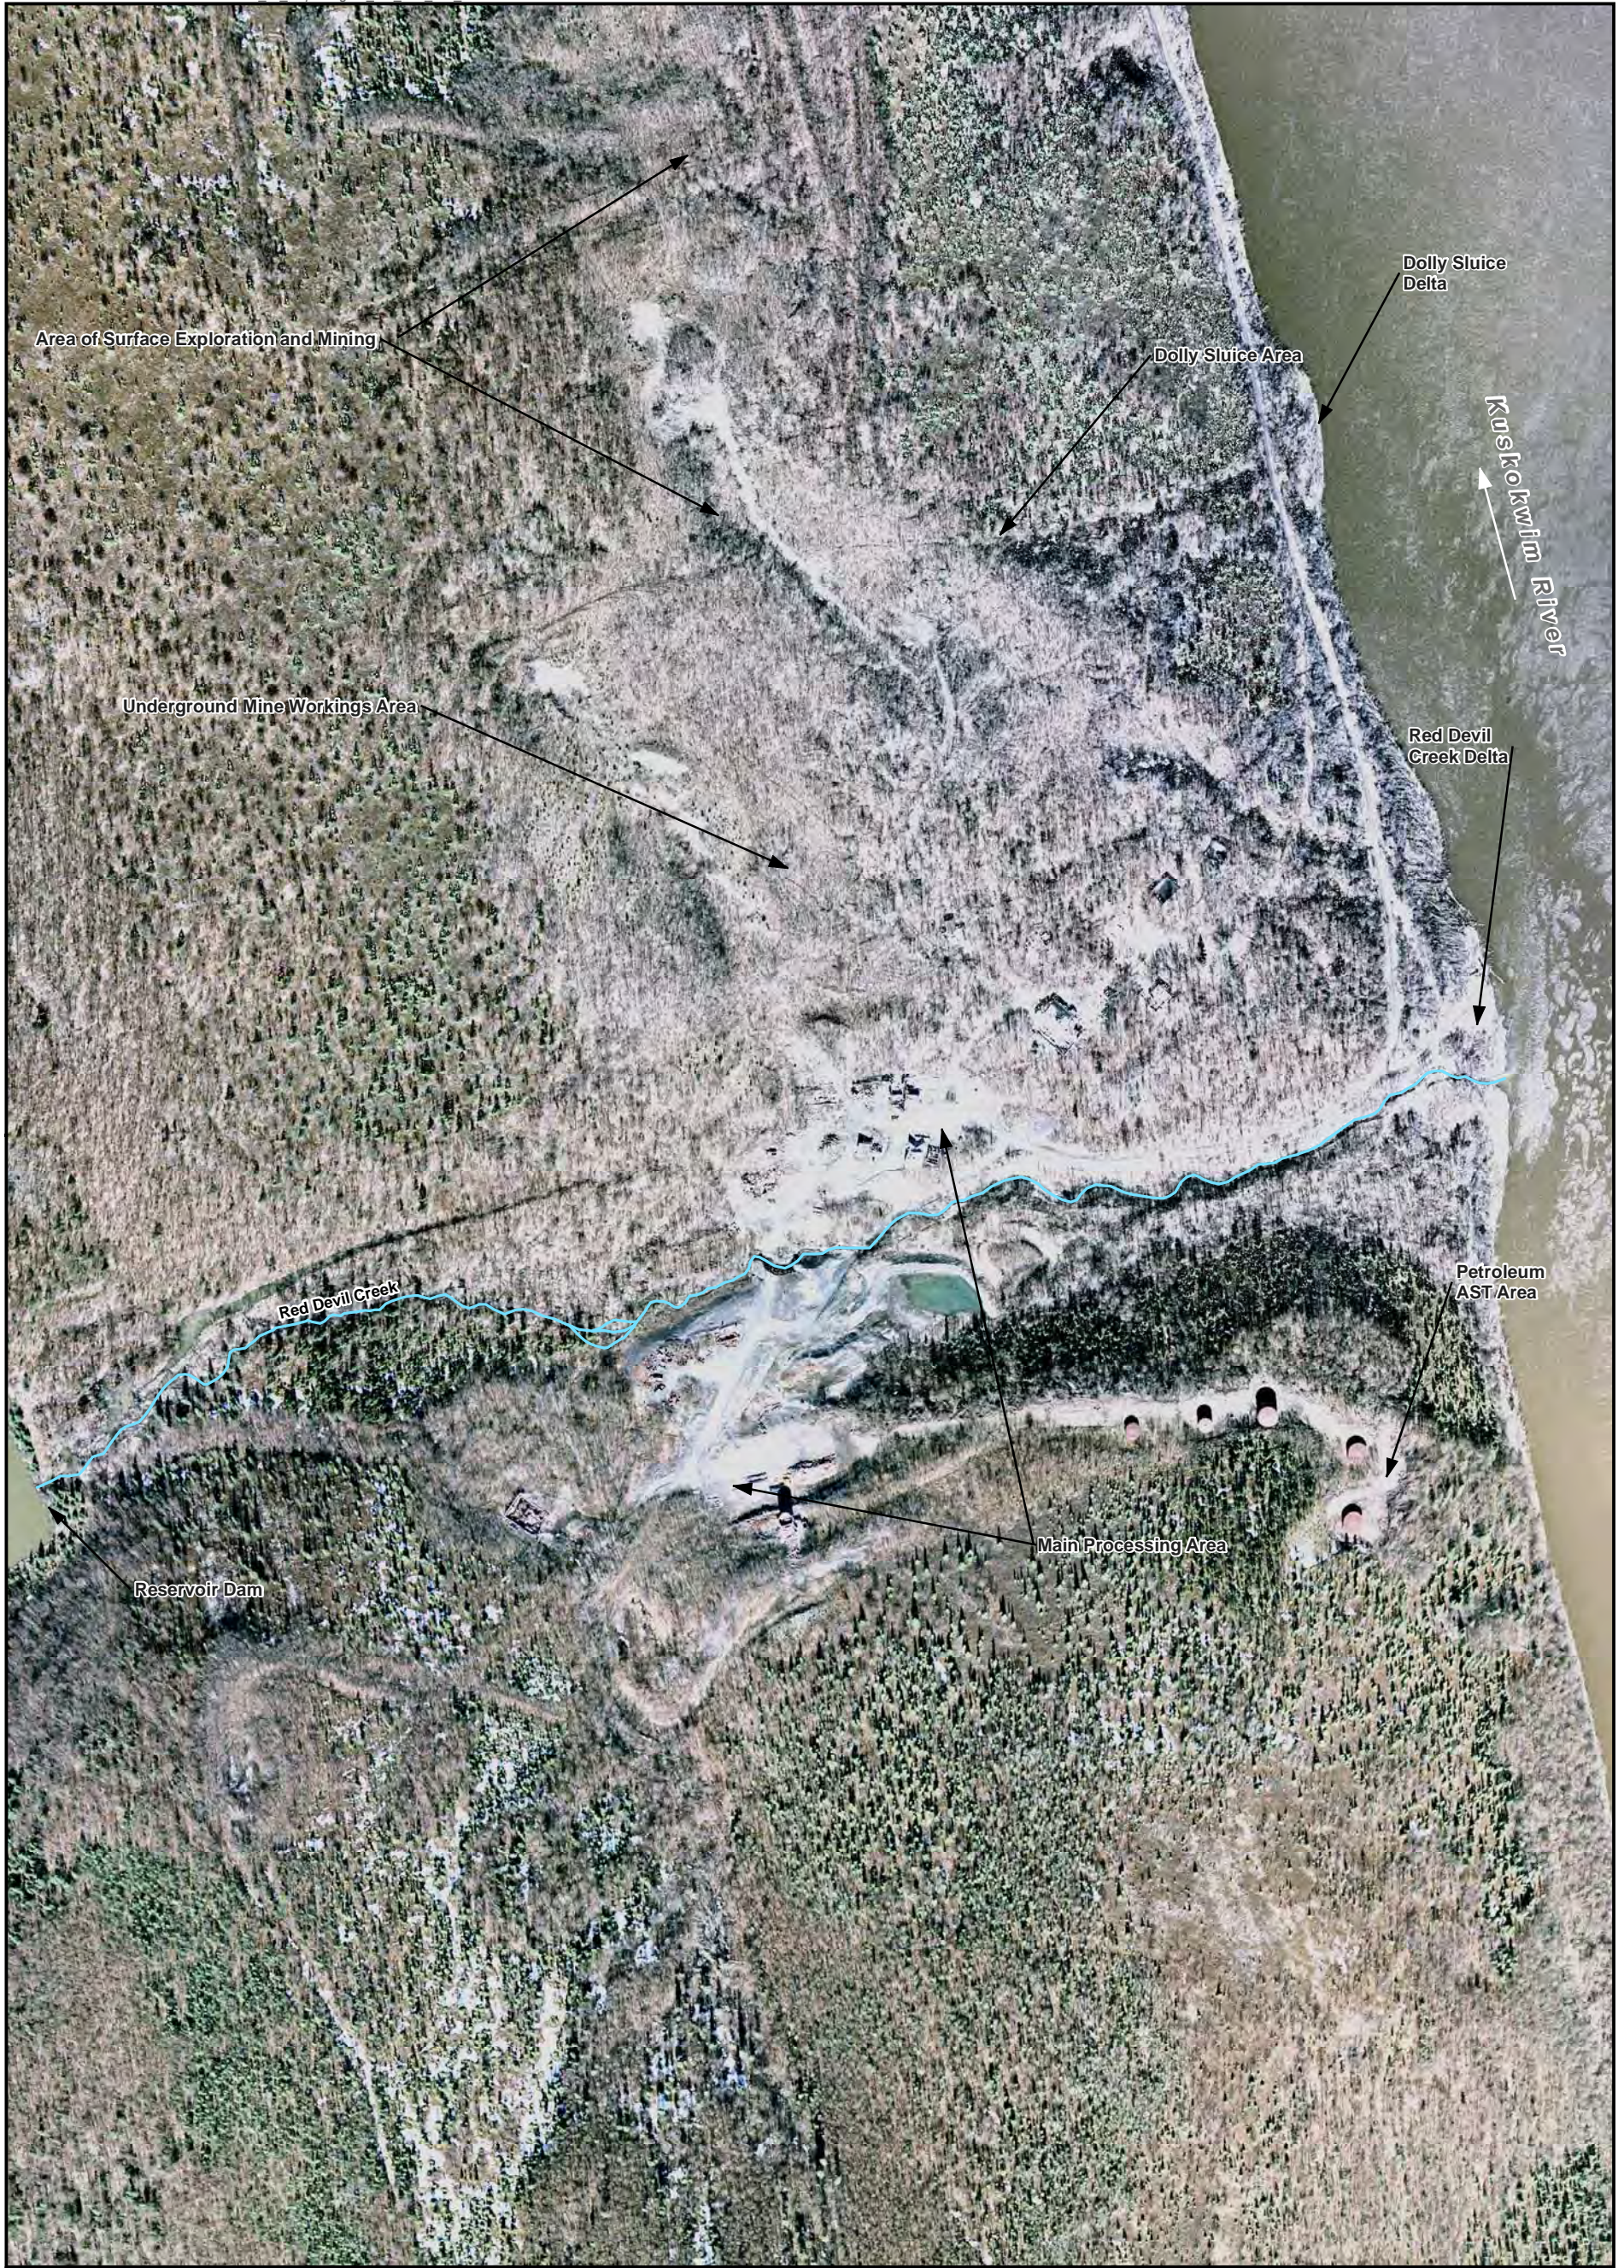
Figure 1-2
Site Area

Figure 1-2 illustrates the site area and the major features identified above based on an aerial photograph taken in 2001 (Aero-Metric, Inc. 2001).

As noted previously, thermal ore processing equipment, generators, and the on-site powerhouse were fueled with diesel stored in five ASTs located northeast of the Main Processing Area (see Figure 1-2).

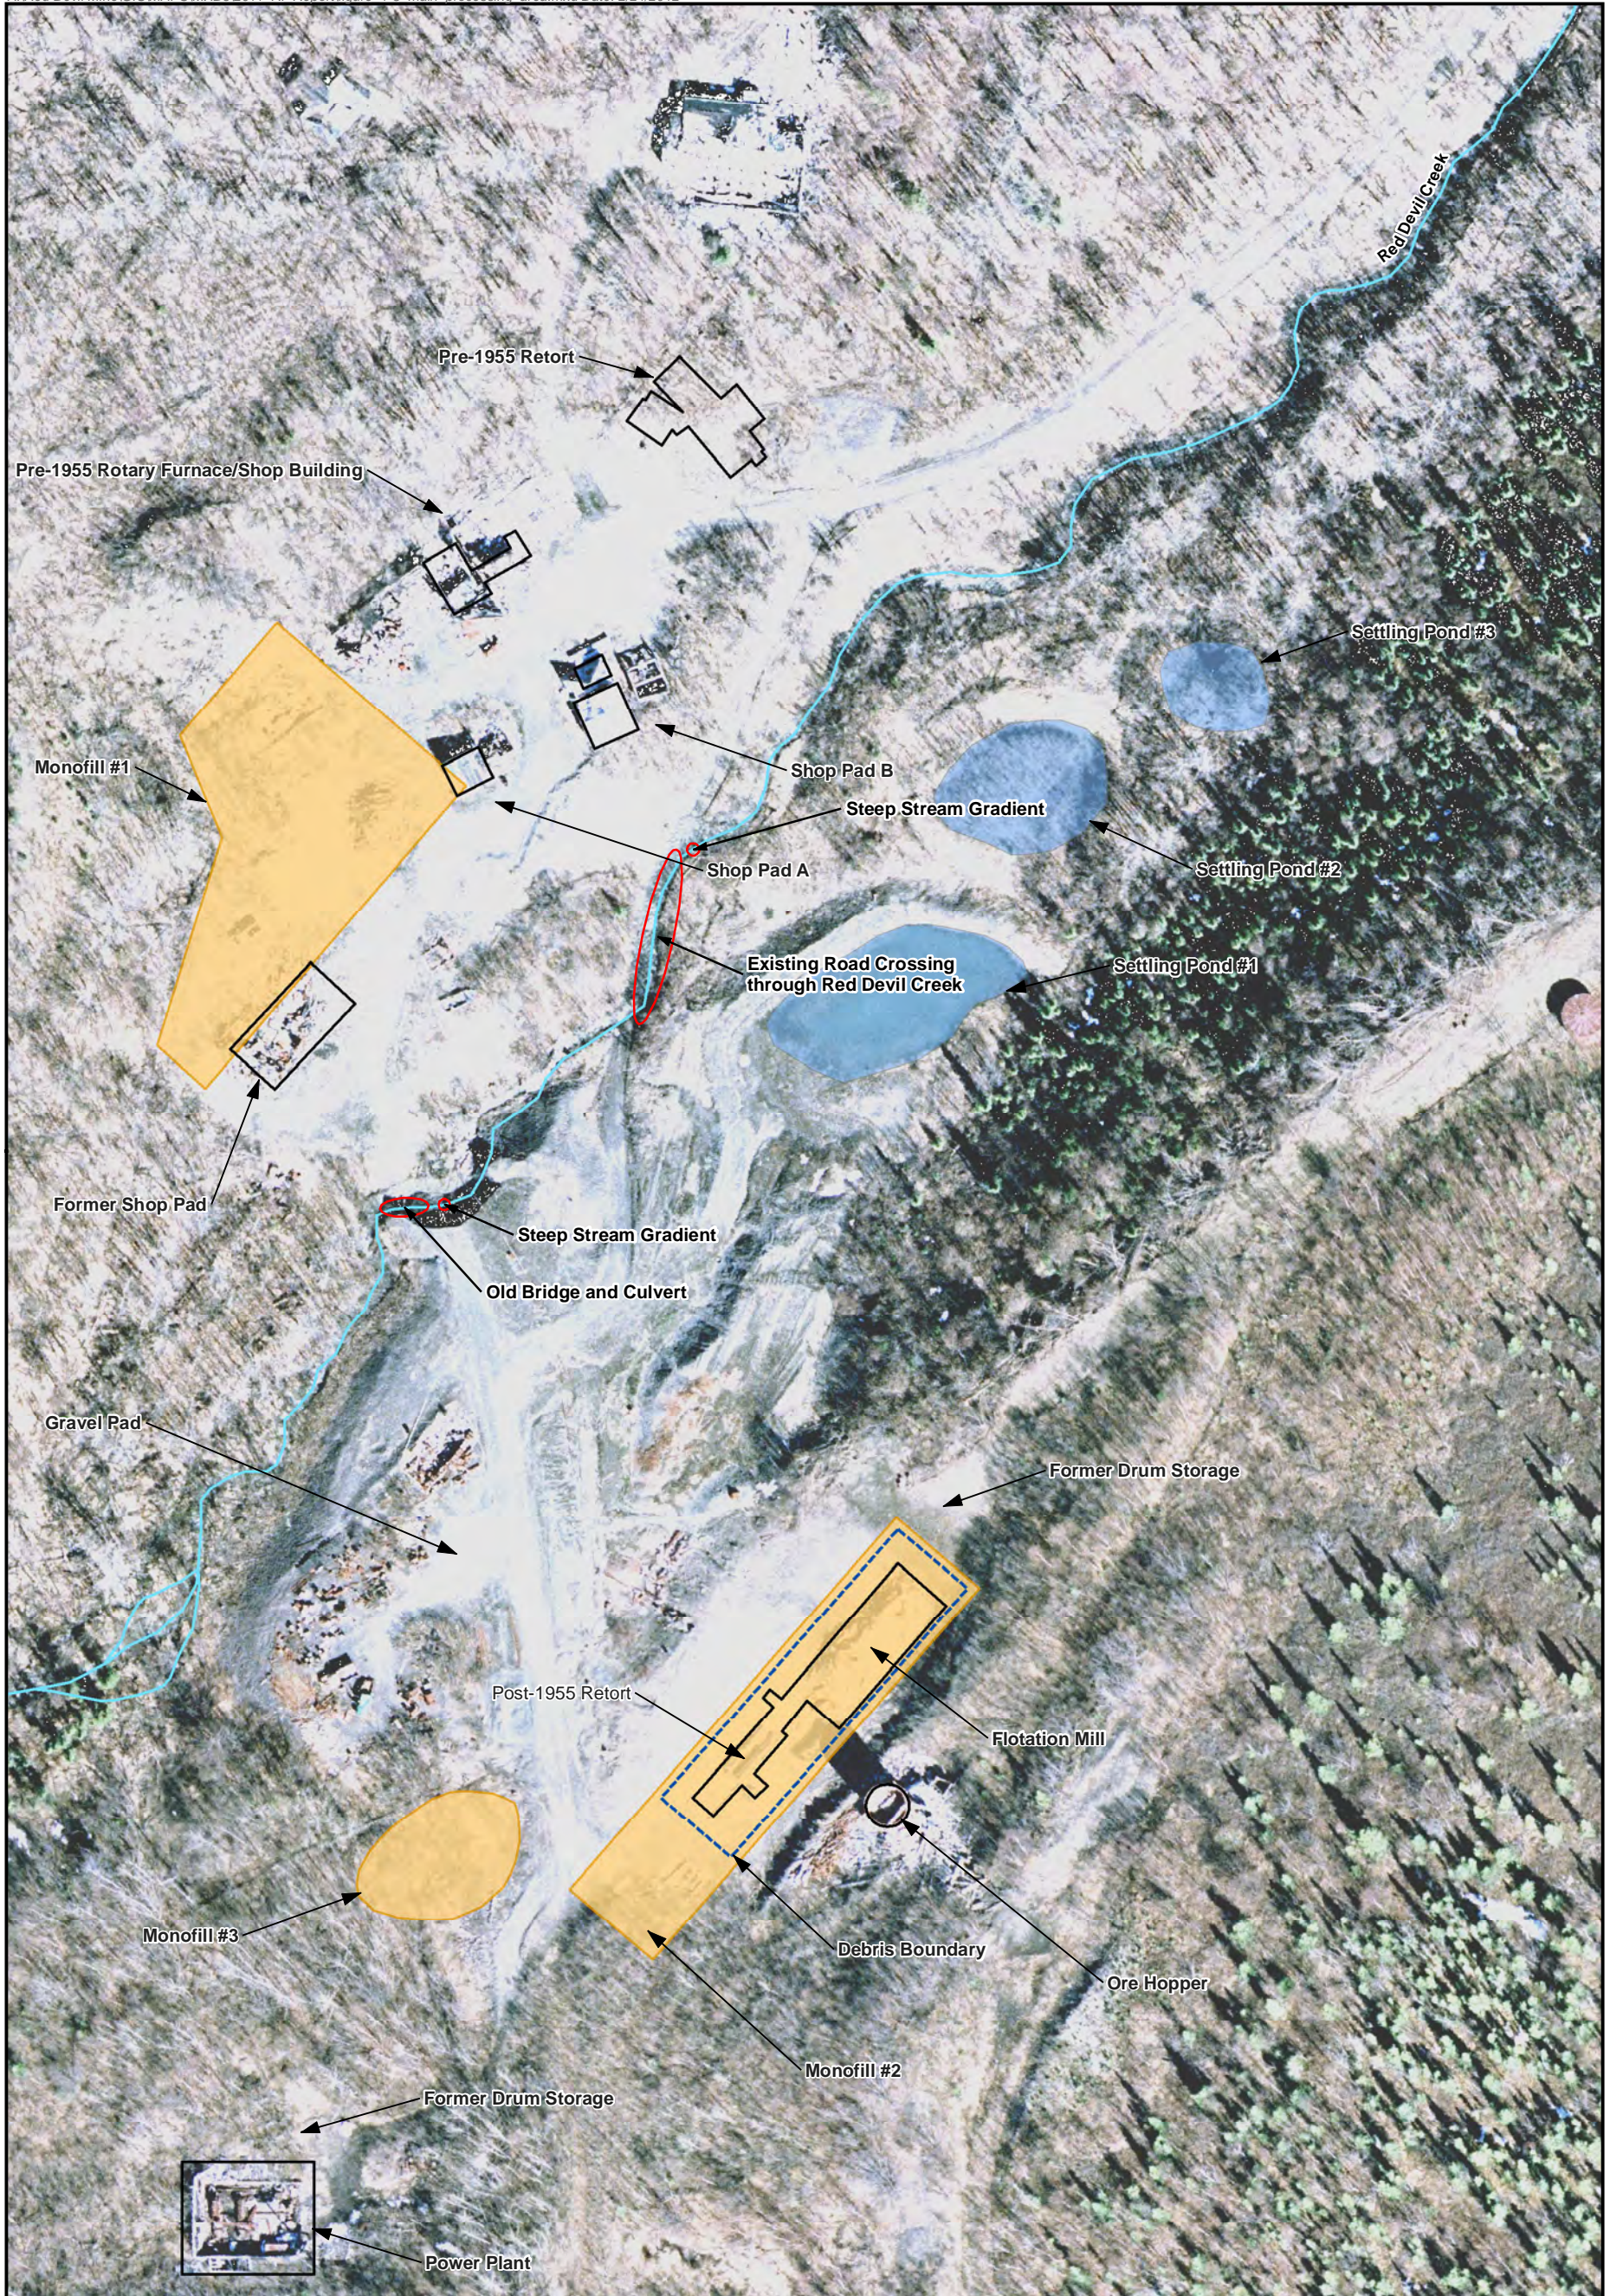
Figure 1-3
 Main Processing Area

- Debris Boundary
- Settling Pond
- Monofill
- Historical Structure

In 1999, Wilder and HLA conducted limited waste removal and site characterization activities to address the most hazardous conditions observed at the site during the 1988 SI. The following subsections summarize the waste removal activities conducted, by waste type; the information source through Section 3.1.2 is Wilder/HLA 1999. Site features referred to within this section are depicted in Figure 1-3.
