# 2

## Site Characterization

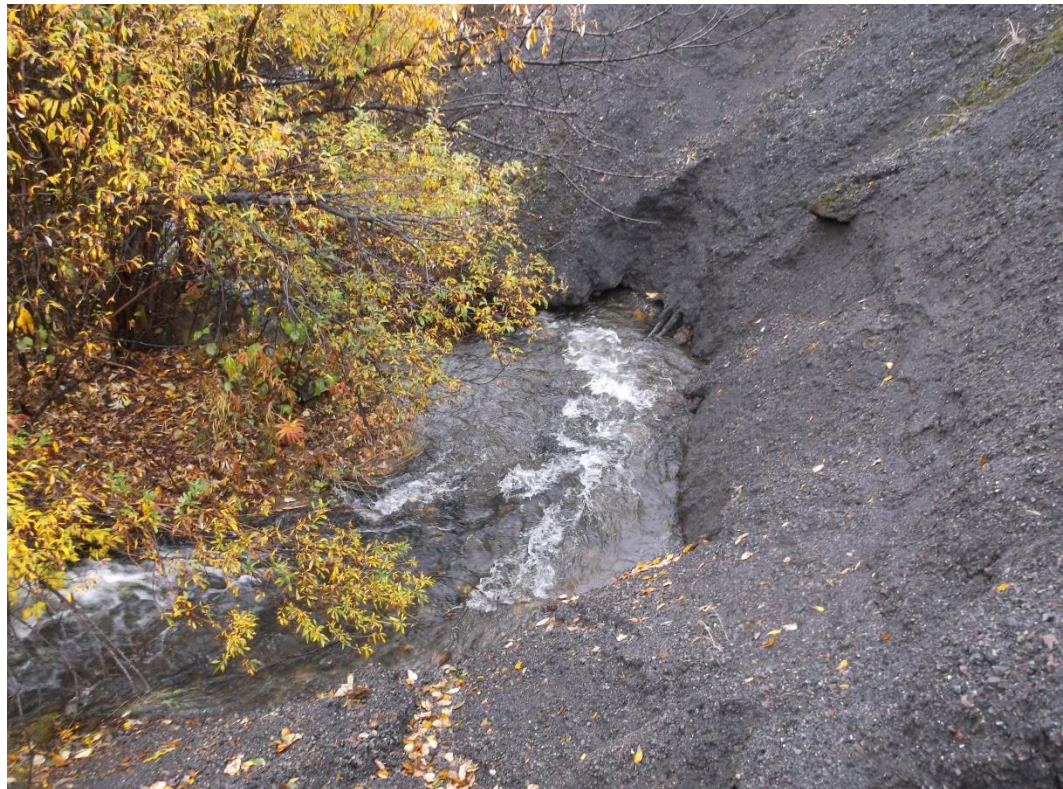
*Tailings erosion into Red Devil Creek.*

This early action EE/CA will present alternatives to deal with the actively eroding tailings that have been observed in the Main Processing Area in order to mitigate further off-site migration of contamination observed within the Kuskokwim River sediment samples (see section 2.4.3 below). Figure 2-4 shows the sediment sample results that were collected along Red Devil Creek within the Main Processing Area where historically a considerable volume of tailings have deposited within Red Devil Creek due to erosion of the stream banks and adjacent tailings piles, as well as due to the collapse of the old bridge at the RDM site just upstream of the Main Processing Area. This segment of Red Devil Creek was also observed to be actively eroding contaminated material into surface waters during recent field investigations and is anticipated to continue being a primary source of contaminated sediment to the Kuskokwim River.

Tailings/waste rock have historically been disposed of or eroded into Red Devil Creek. In addition, natural ore minerals, particularly from the Surface Mined Area, have been eroded and transported into Red Devil Creek. These tailings and natural materials have been deposited with and transported down the channel of Red Devil Creek and into the Kuskokwim River, where they accumulate in a delta. Sluicing of overburden from the Surface Mined Area created the Dolly and Rice Sluice deltas in the Kuskokwim River. These materials have migrated down river to some extent. Tailings and waste rock that enter Red Devil Creek by erosion and mass wasting have been in the past, as well as currently, subject to surface water transport downstream.
